# Failure analysis of turbine disc of an aero engine

Lucjan Witek \*

*Faculty of Mechanical Engineering and Aeronautics, Rzeszow University of Technology, 8 Powstańców Warszawy Avenue,  
35-959 Rzeszów, Poland*

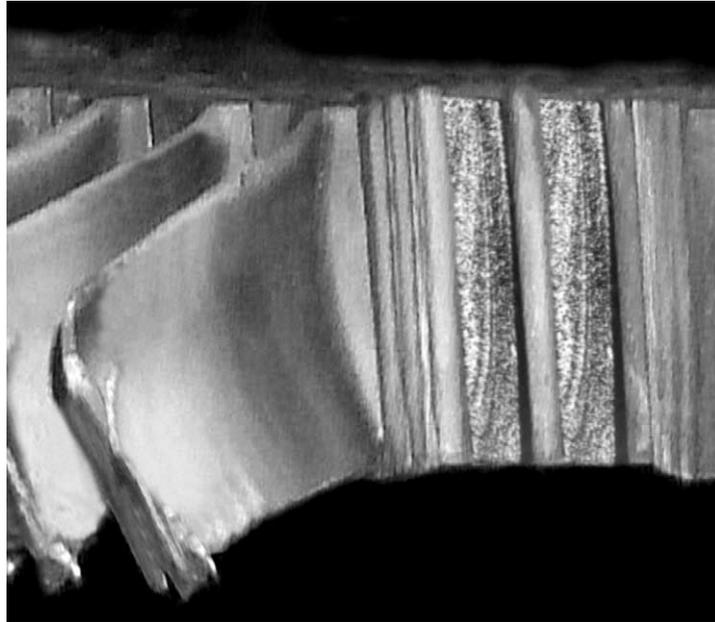
The fractured disc was first subjected to visual examination. The disc failure location is presented in Fig. 2. As seen from this figure, the disc first fractured in the zone of the lower fir-tree slot of the serrations. After that, small fractured pieces of disc in common with the three separated blades damaged the other blades. These damaged blades are visible in Fig. 2.

Fig. 2. View of the fractured disc.

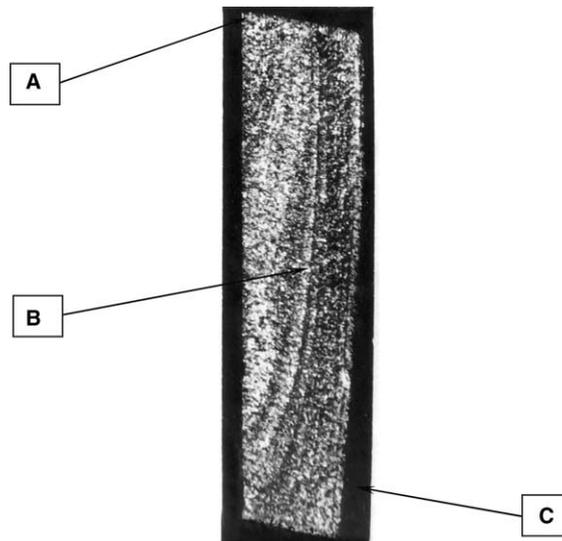
Fig. 3 is a magnified view of the lower fracture surface. The curvature of the beach marks indicated that the incremental crack growth had taken place from the corner of the lug fracture region (zone A in Fig. 3). The fractured surface showed a clear difference in colour in two different regions. The crack origin zone, the fatigue fracture area with beach marks, and the ruptured zone are marked A, B and C, respectively. The region, which finally ruptured, is dark grey (C).

Fig. 3. Magnified view of the fractured surface.

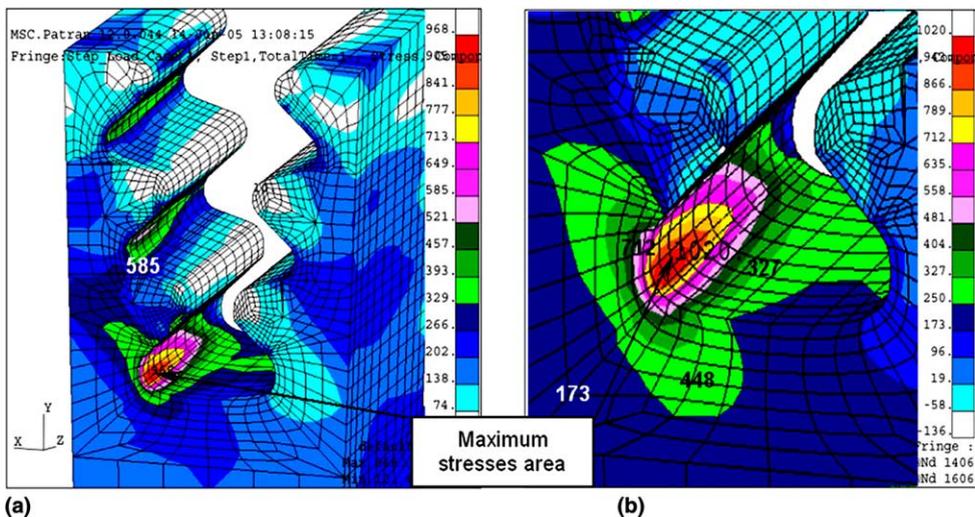
Fig. 7(a) shows that the area of the maximum Von Mises stress (968 MPa) for the operational speed of 12,500 rpm is located on the corner of the 3rd lower slot of the disc. The value of maximum principal stress for this critical zone is 1020 MPa (Fig. 7(b)). The value of maximum principal stress for this critical zone is 1020 MPa (Fig. 7(b)). The second result (Fig. 7(b)) is particularly interesting from the point of view of the fatigue strength because just the tensile stresses contribute the most to the fatigue crack and then to crack propagation. The Von Mises stress distribution does not show if the material is in tension or compressed. The location of the stress peak shown in Fig. 7 overlaps the fracture region presented in Fig. 2. The high level of stress in this area was the main reason for crack initiation in this region of disc. The fatigue loads (combination of the low cycle fatigue (LCF), thermal fatigue (TF) and high cycle fatigue (HCF)) caused the successive growth of the crack to critical size and then to rupture in the lower slot of the serrations.

Fig. 7. Von Mises (a) and maximum principal (b) stress distribution in the vicinity of the serration area of disc for speed of 13,500 rpm.

slot of the dovetail-rim region of the disc, where the maximum stress was observed. Fracture of the disc in this zone can occur in the speed range of 14,500–16,000 rpm due to excessive stresses. Damage of the turbine wheel is possible also at lower speed, when the volume of the disc will contain a preliminary fatigue crack. However, accurate estimation of the maximum permissible speed as a function of crack size is possible only with a fracture mechanics analysis.

- (a) Increase the radius of the lower slot of the serration fitting.
- (b) Change the dimensional tolerance of the dovetail-rim area of the turbine to unload the critical zone of the 3rd lower slot of the disc.

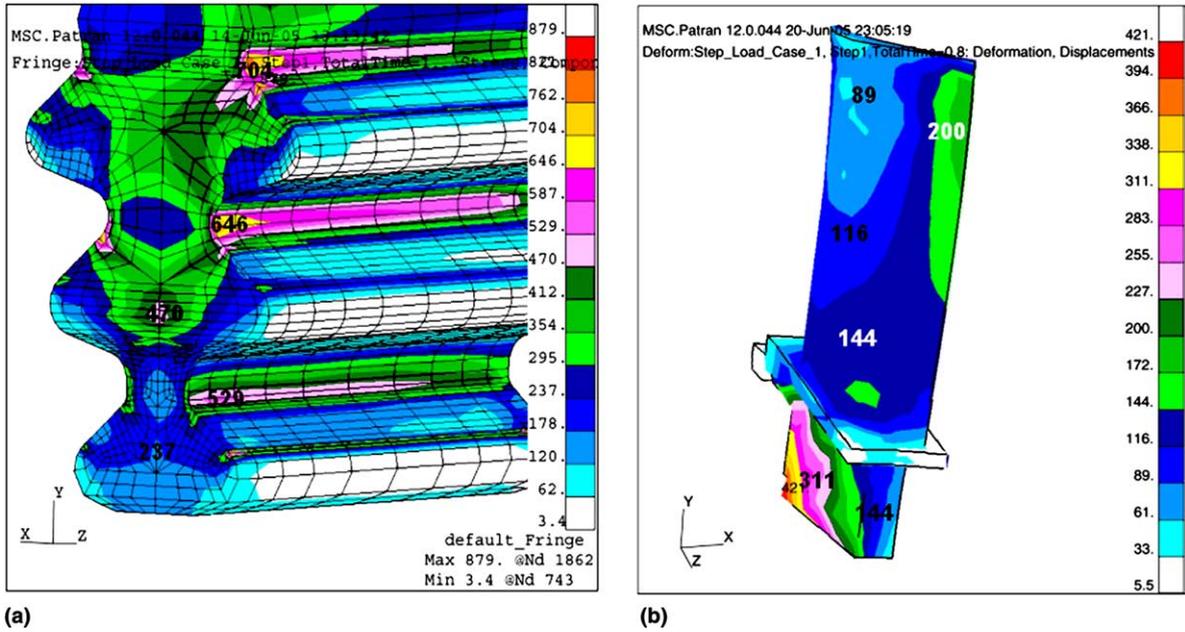
A considerably lower value of stress (704 MPa) in the region of the fir-tree slots of blade can be observed in Fig. 8(a). The remaining zones of blade are not as highly loaded as the serration region. The maximum Von Mises stress in the middle region of the blade is only 400 MPa, whereas in the top the stresses have a range of 100–200 MPa (Fig. 8(b)).

Fig. 8. Von Mises stress distribution in the fir-tree slots of blade (a) and for top part of blade (b), 13,500 rpm. The stresses are displayed on the deformed model with visualization scale of 25:1.

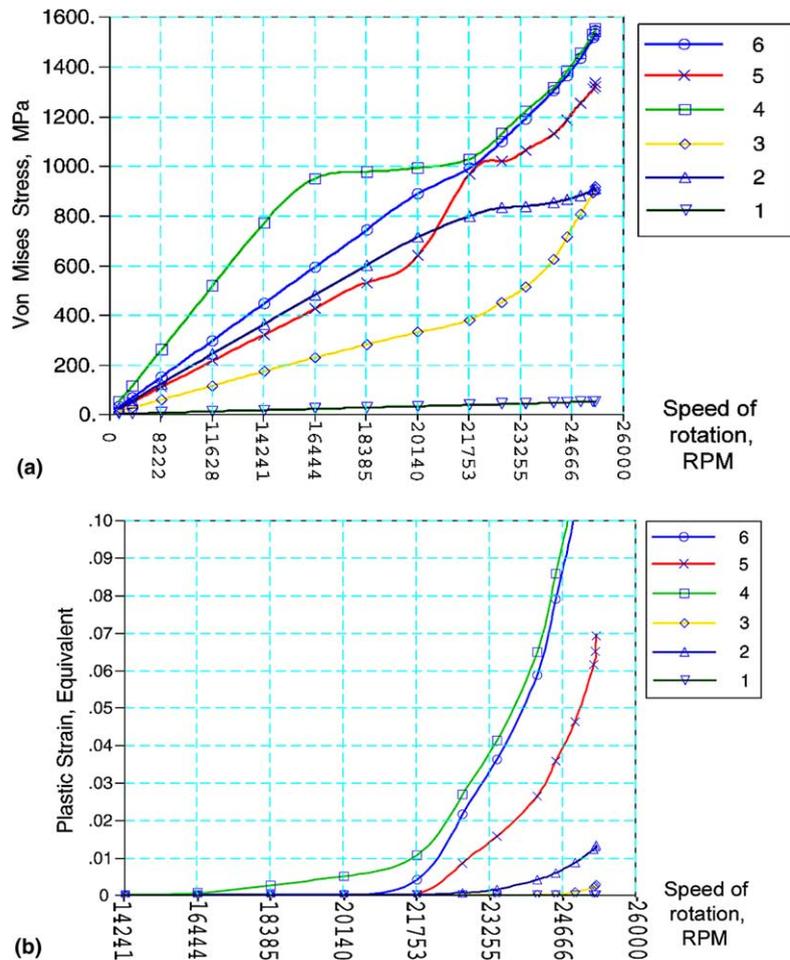
According to the FEA simulation, Fig. 10(a) illustrates the values of Von Mises stresses for specified characteristic points of turbine for the speed range of 0–25,000 rpm. As seen from this figure, the curve nr 4, defined for critical region of disc has a maximum rate of stress increase for the speed range of 0–16,000 rpm (maximum, operational speed for considered turbine engine is 12,200 rpm). The clear change

Fig. 10. Von Mises stress (a) and plastic strain magnitude (b) vs. rotational speed of turbine for selected control points.

of the line (nr 4) gradient at 16,000 rpm is related to the first plastic yield area in the lower fir-tree slot of the disc (see Fig. 10(b)).

The constant rate of plastic strain increase (Fig. 10(b)) is observed for the line nr 4 from 16,000 rpm until about 20,000 rpm. The next plastic strain area occurs at 20,000 rpm in the bottom part of the disc (point nr 6 in Fig. 10(b)). For 21,753 rpm, the plastic yield area enlarges and reaches the central part of the disc (point nr 5).
