**MAHLE**

# ENGINE COMPONENTS AND FILTERS: DAMAGE PROFILES, PROBABLE CAUSES AND PREVENTION

Technical Information

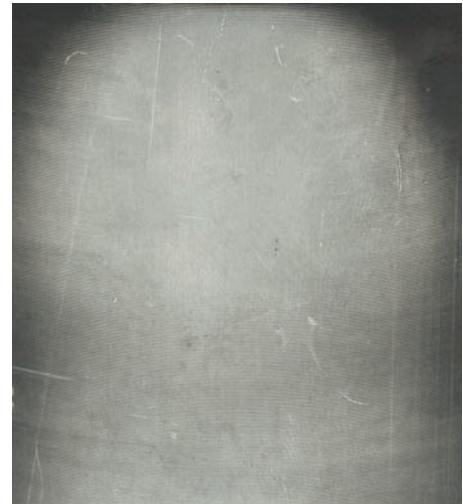
- The piston skirt displays a scuffing, wide wear pattern on the thrust and opposite side (Fig. 1).
- The machining profile at the piston skirt (Fig. 2) and at the contact surfaces (cylinder wall or cylinder liner) has been removed (Fig. 3).
- The piston skirt, piston rings, cylinder wall and/or cylinder liner display fine scoring marks in the running direction.
- The piston rings and groove walls are heavily worn (Fig. 4).
- There is a large end gap at the piston rings. The edges of the rings are razor sharp.
- The faces of the oil control ring are worn (Fig. 5).
- The piston pin shows longitudinal scoring marks with a wavelike profile (Fig. 6).
- Wear caused by contamination can also be found on other components, for example at a valve stem (Fig. 7).

Several types of wear caused by contamination can be distinguished depending on the number of damaged cylinders and the amount of the piston ring wear:

**... and the top ring is more worn than the oil control ring,** contamination has reached the combustion chamber via the intake system of one cylinder, i.e. from above. This is caused either by a leak or debris which was not removed prior to assembly.

**... and the top ring is more worn than the oil control ring,** contamination has reached the combustion chamber via the common intake system of all the cylinders. This is either due to leaks and/or a defective or missing air filter.

**... and the oil control ring is more worn than the top ring,** contaminated engine oil is the culprit. The oil is contaminated either due to an uncleaned crankcase and/or a dirty oil mist separator.

Fig. 1  
Wear caused by contamination at the piston – longitudinal scoring marks

- Check the intake system for leaks.
- Check the air filter and, if necessary, replace it.
- Clean the crankcase and the intake manifolds prior to assembly.
- Always pay attention to cleanliness during assembly.

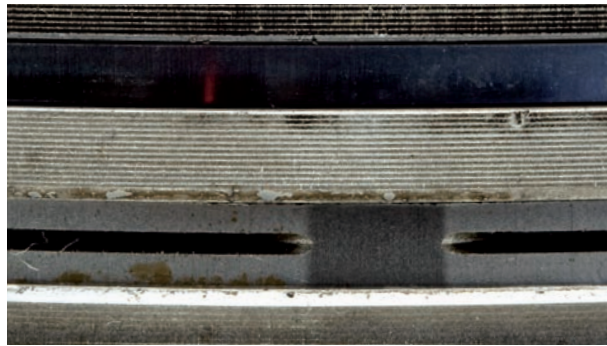
Fig. 4  
Axial wear at the piston rings

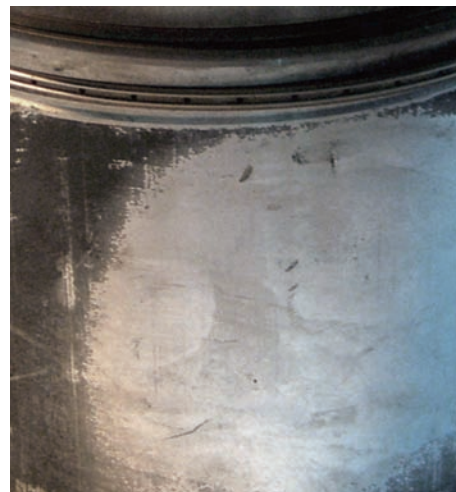
- The wear pattern is wide, shiny and shows deep scoring marks along the entire piston skirt (*Fig. 1*).
- Scoring marks on the piston rings, possibly additional burn marks on the piston ring surface (*Fig. 2*).
- The honing in the cylinder liner or cylinder running surface is heavily worn (*Fig. 3*).
- Heavy wear marks are visible at the piston pin. Pitting visible in the pin bore (*Fig. 4a+b*).

An excessive amount of fuel in the oil dilutes the oil film, thus drastically reducing its load-bearing ability and increasing engine component wear. This type of damage can have the following causes:

- The injection system is set incorrectly.
- Cold start enrichment is too rich.
- The injection nozzles are functioning incorrectly, e.g. due to a clogged fuel filter.
- Due to an excessive protrusion, the piston hammers the cylinder head, causing uncontrolled injection.
- The compression is weak. This can be attributed to the following conditions:
  - A valve is leaky.
  - The cylinder head gasket is leaky.
  - The timing is set incorrectly.
  - The protrusion is too small.
  - One piston ring or several piston rings are defective.
  - An error has occurred in the ignition system, e.g. a defective spark plug.

*Fig. 1*  
Wide wear pattern and scoring marks due to fuel dilution

- Set the injection system correctly (cold start enrichment, etc.).
- Check the injection nozzles.
- Installation dimensions must be observed.
- Always adhere to fuel filter maintenance intervals, and shorten the time between intervals accordingly in extreme conditions.
- Check the spark plugs and, if necessary, replace them.

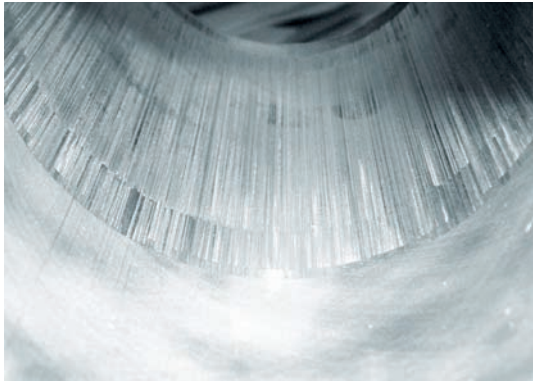
*Fig. 3*  
*Scoring and seizure marks in the cylinder bore*

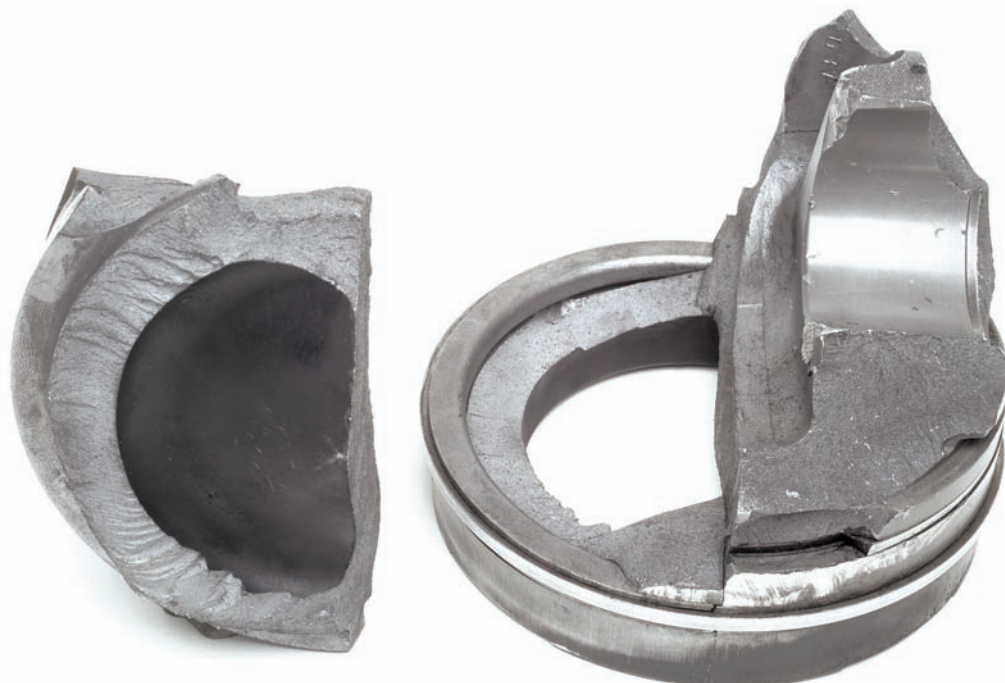
- The piston is broken or deformed (*Fig. 1*).
- The connecting rod is bent or broken (*Fig. 2*).
- The piston ring land of the piston concerned shows an overload fracture (*Fig. 3a+b*).
- The piston pin is broken.

This damage is caused by liquid. Water or fuel reaching the combustion chamber. Since neither water nor fuel can be compressed, hydraulic lock results in an abrupt stress load at the piston, the piston pin, the connecting rod, the cylinder head, the crankcase, the bearing and the crankshaft. Excessive liquid may reach the combustion chamber due to the following reasons:

- Water reaches the combustion chamber via the intake system (e.g. when driving through water).
- Cooling water enters the combustion chamber due to defective gaskets.
- Excessive fuel reaches the combustion chamber due to a defective injection nozzle.

*Fig. 1*  
Broken commercial  
vehicle piston due to  
hydraulic lock

- Always use new and undamaged gaskets when overhauling an engine. Defective gaskets must be replaced.
- Always check injection nozzles and, when necessary, renew them.

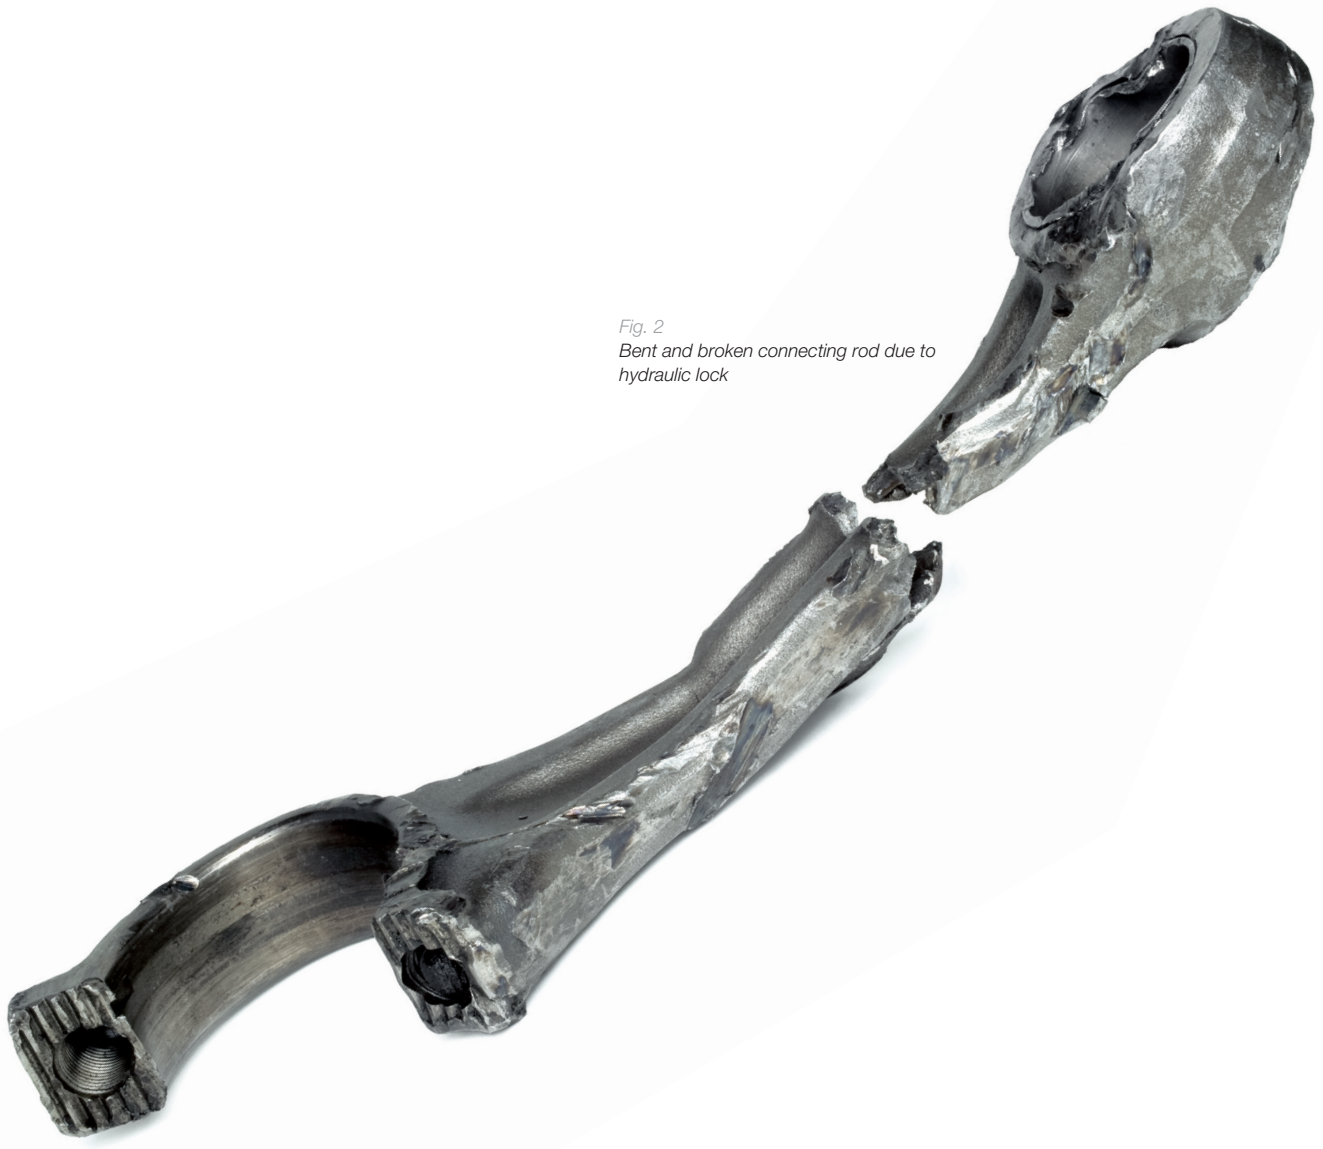
Fig. 2  
Bent and broken connecting rod due to hydraulic lock

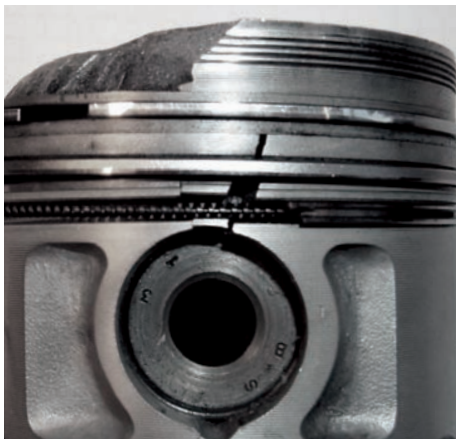
Fig. 3a  
Overload fracture from the top of the piston to the pin bore

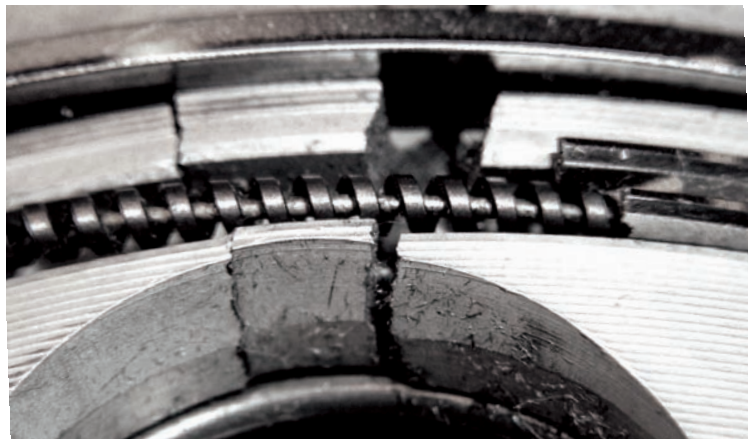
Fig. 3b  
Close-up view of an overload fracture

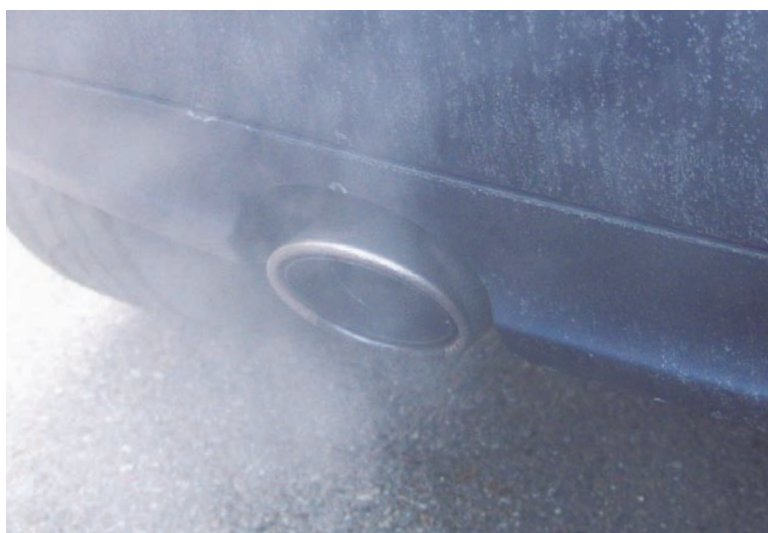
Fig. 2  
A smoky exhaust pipe

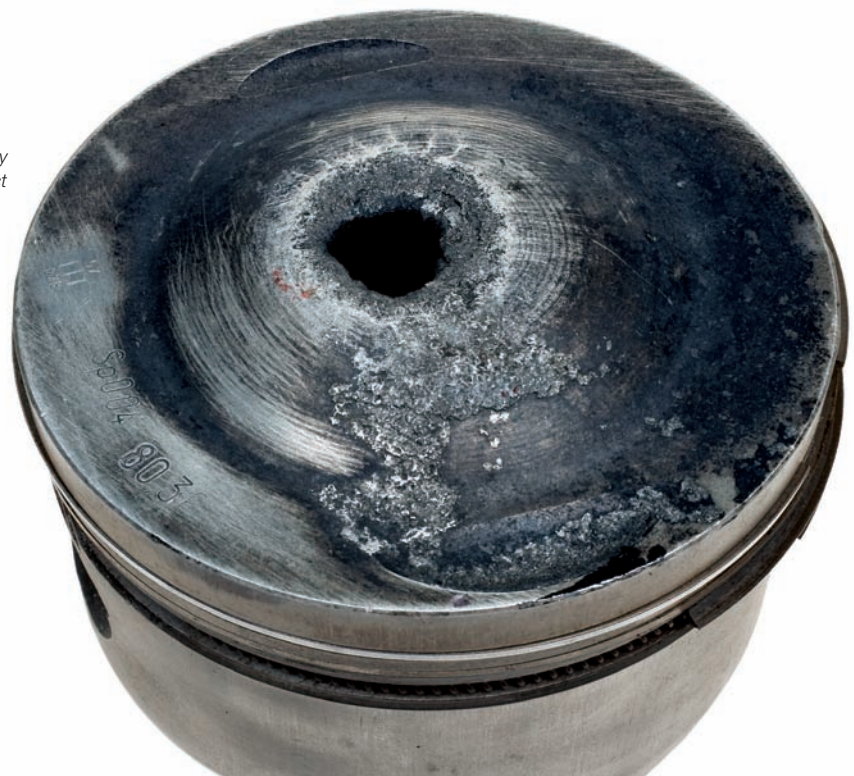
- There is a hole in the top of the piston (*Fig. 1*).
- The surface surrounding the hole is coated with melted piston material.
- The top land has melted (*Fig. 2*).
- The top of the piston has melted and the piston ring belt has partially burned-through (*Fig. 3*).

The damage is caused by localized hot spots. However, it is important to differentiate between gasoline and diesel engines.

*Fig. 1*  
Hole in the top of the piston, caused by the use of spark plugs with an incorrect heat value

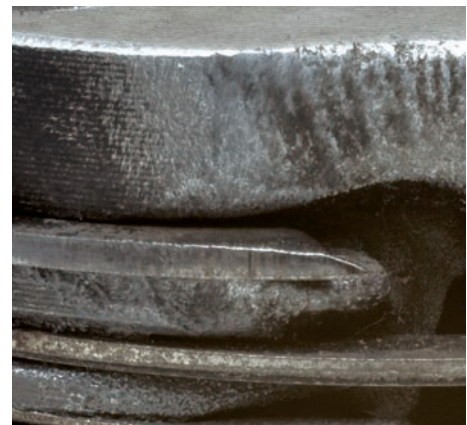
*Fig. 1*  
Erosion at a gasoline piston

- Only use fuel with the specified octane rating.
- Set the injection system, the carburetor and the ignition correctly.
- Only use spark plugs which correspond to the manufacturer's specifications.
- Check the intake system for leaks.
- Use a thicker gasket for a re-machined cylinder head, and ensure the compression height is less for oversize pistons.
- Pay attention to the correct charge-air pressure for a turbocharged engine.

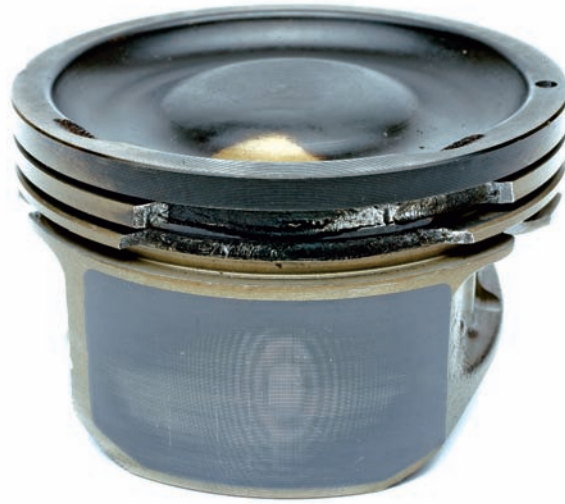
Fig. 2a  
Broken piston ring lands

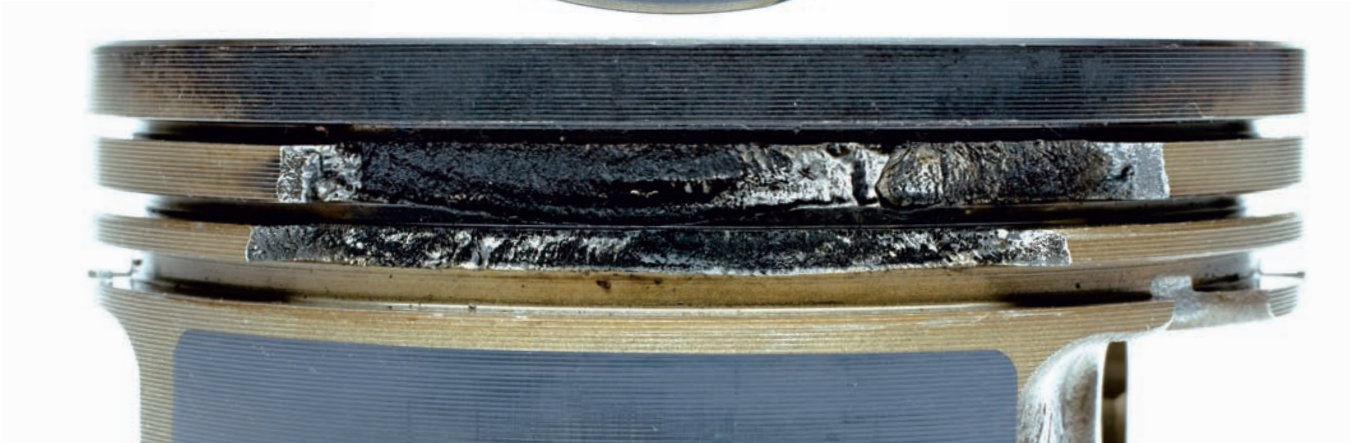
Fig. 2b  
Close-up view of the broken piston ring lands

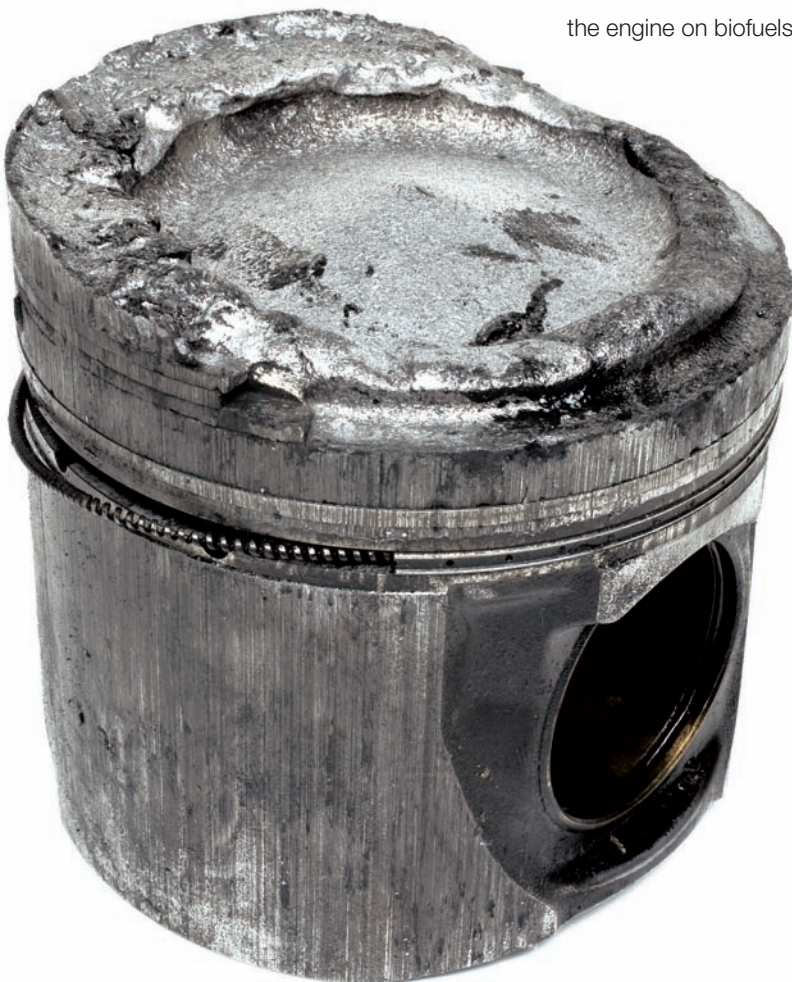
Fig. 2  
Melted piston crown at a diesel piston

- Set the injection amount and timing according to the manufacturer's specifications.
- Check the injection nozzles for any leaks, the injection pressure and the spray pattern.
- Pay attention to correct alignment when assembling the cooling oil nozzles.
- Thoroughly clean the oil channels in the engine block, the crankshaft and the cylinder head.
- Make sure the pressure regulating valve is functioning correctly.
- Ensure that the time between oil changes is much shorter when running the engine on biofuels.

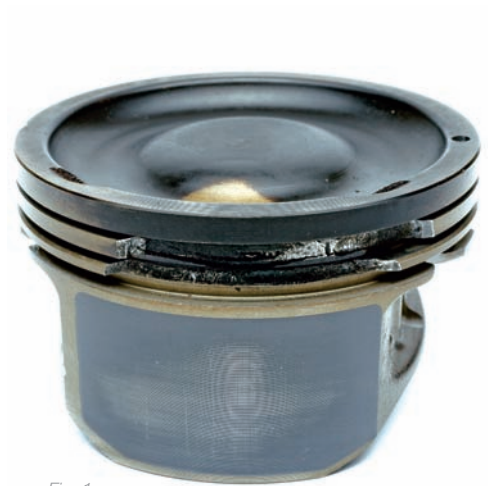
Fig. 1a  
Broken piston ring lands caused by an abnormal combustion

- If the piston rings have been installed without using a ring compressor, they are quite often not properly seated in the groove. During subsequent installation of the piston in the cylinder, the rings protrude fractionally, thus blocking the front of the bore. A typical bottom to top fracture of the piston ring lands occurs.
- With a two-stroke engine the fracture runs from top to bottom, as the piston is forced into the cylinder from the underside.

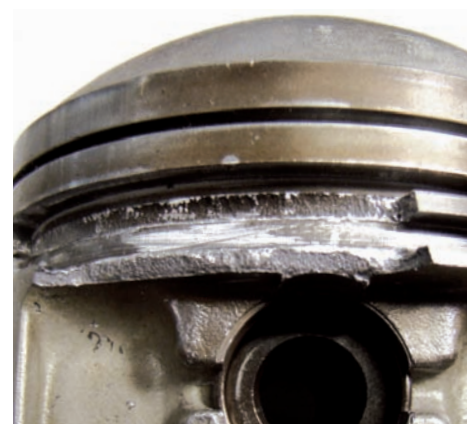
Fig. 1b  
Close-up view of the fracture behaviour from top to bottom

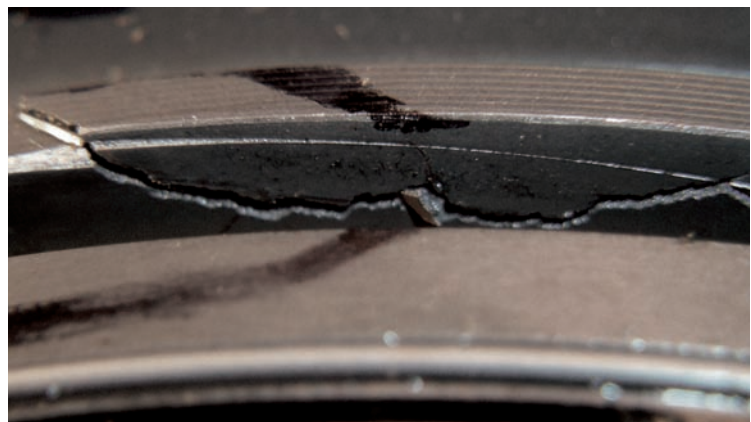
Fig. 3  
Assembly error with an imprint of the piston ring

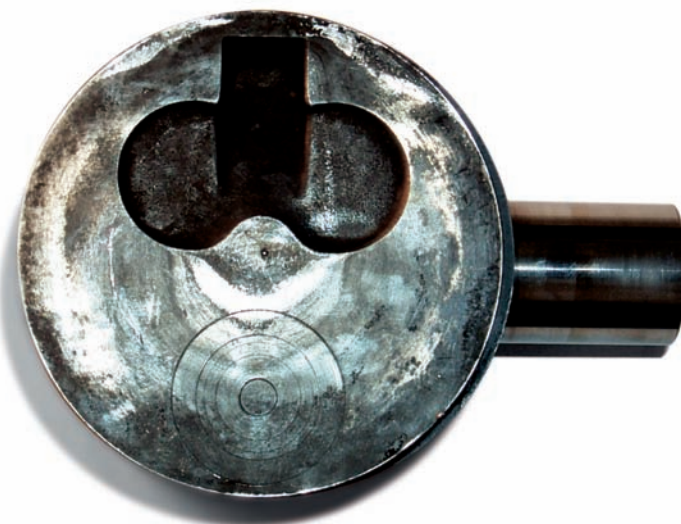
Fig. 1  
Top of the piston with valve impact

- Set the timing correctly during installation.
- Check the protrusion at all the cylinders during installation.
- If unusually loud operating noises are audible, switch off the ignition and determine the source of the noise to prevent any consequential damage.

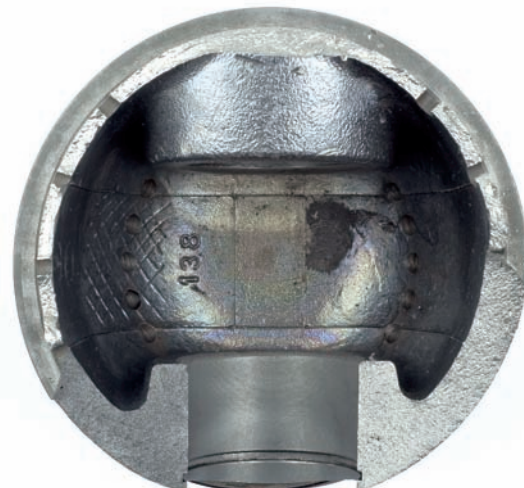
Fig. 3  
Piston snapped off at a right angle at the height of the piston pin axis

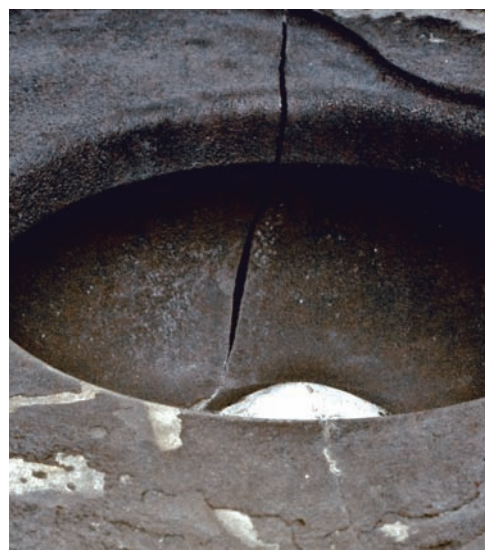
*Fig. 1*  
Cracks in the bowl rim

- Tuning and the required engine modifications should only be carried out by the engine manufacturer or trained and qualified engine tuners.
- Set the injection pump according to the manufacturer’s specifications.

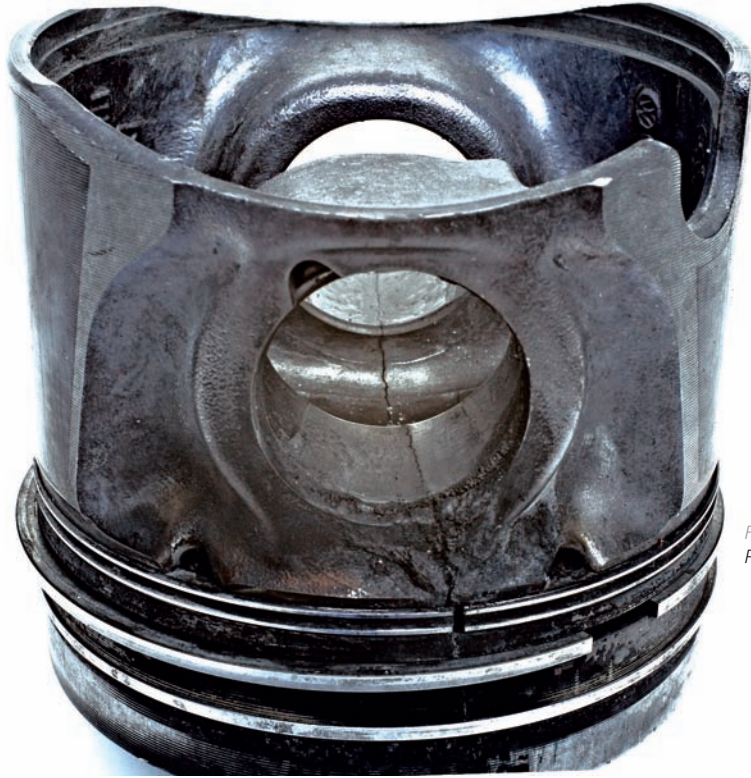
Fig. 2  
Piston fractured right into the pin bore

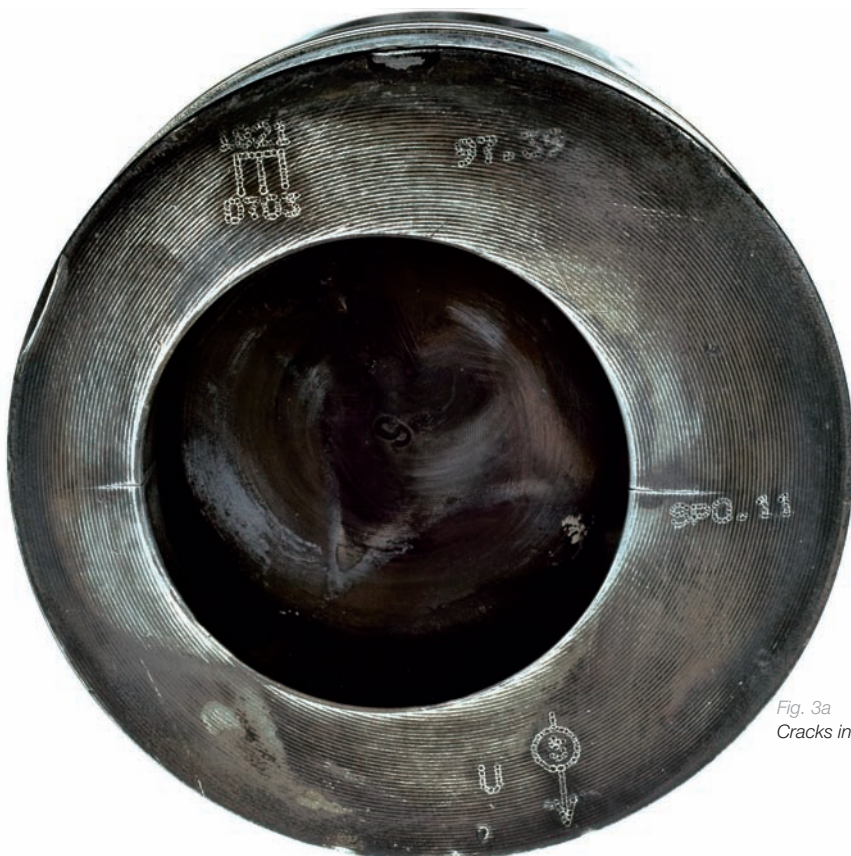
Fig. 3a  
Cracks in the bowl rim

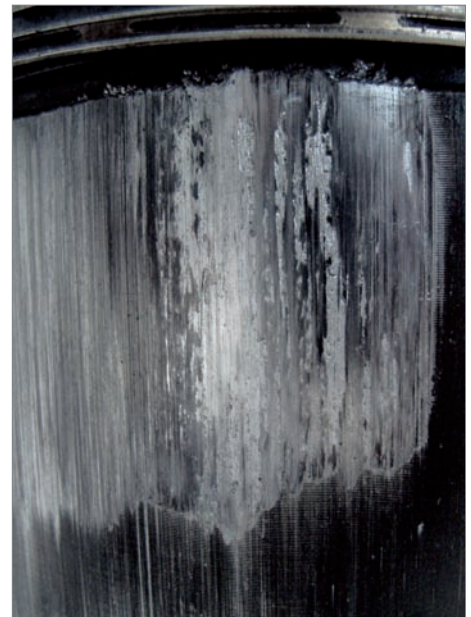
Fig. 2  
Partially shiny seizure marks

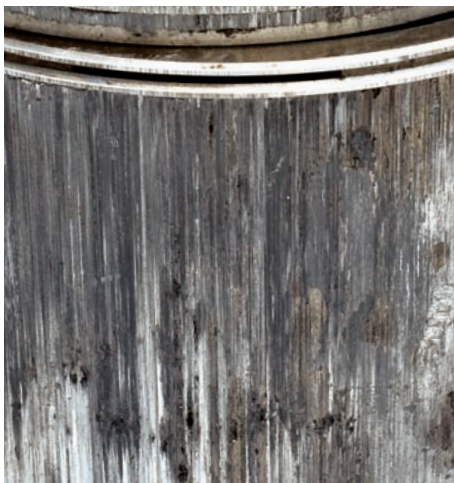
Fig. 1  
Seizure only on the thrust side of the piston skirt

- Ensure a correct supply of oil – and check that the oil feeder holes in the connecting rod are not clogged.
- Only use engine oils approved by the engine manufacturer.
- Operate the engine at a moderate speed and load immediately after assembly.
- Regular oil level checks are imperative; if necessary, refill oil.
- Check the oil pressure. Insufficient oil pressure can be caused by a worn oil pump, a dirty filter, a defective pressure relief valve in the oil pump or diluted oil.
- Check the cooling system.

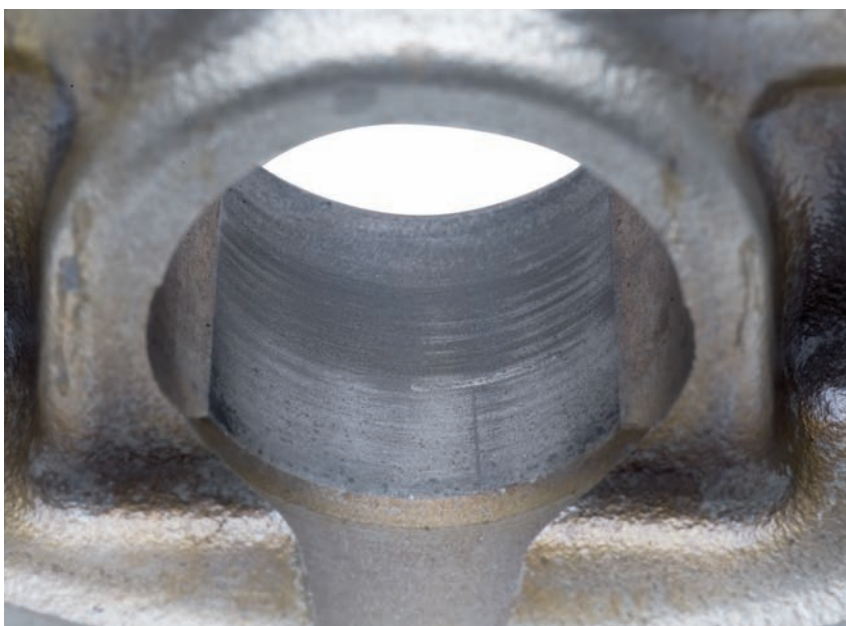
Fig. 3  
Pin bore with seizure marks

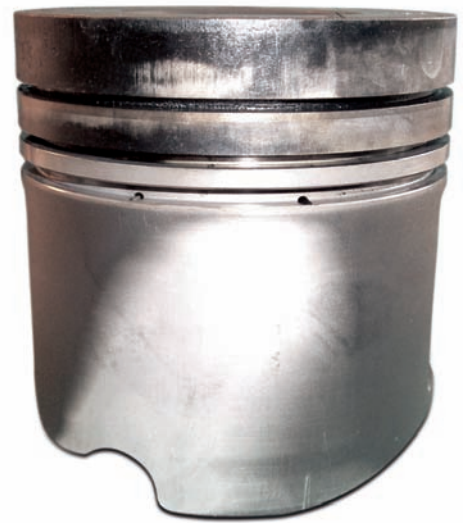
*Fig. 1*  
Asymmetrical wear pattern (slanted position)  
at the piston skirt

- Align the main bearing line, the crankshaft and the connecting rod properly during machining and installation (concentricity).
- Make sure that the connecting rod is aligned correctly.
- Tighten the cylinder head bolts according to the manufacturer's specifications.
- Always pay great attention to cleanliness during engine assembly, e.g. gasket residue must be cleaned up immediately.

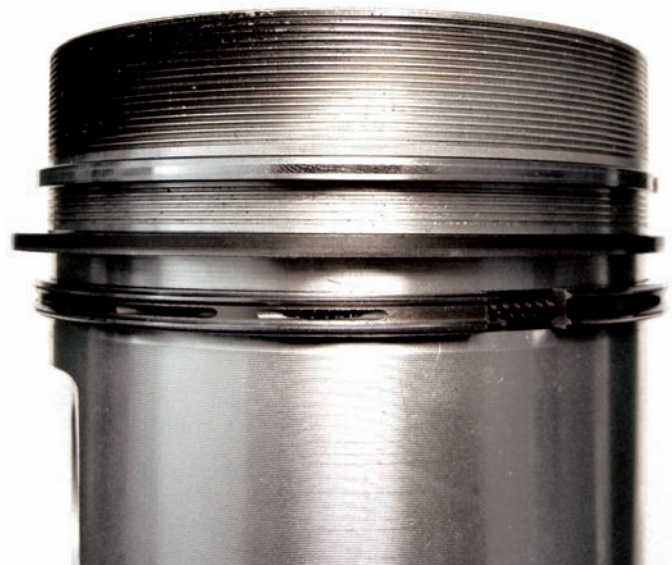
*Fig. 2*  
Top land with irregular  
deposits

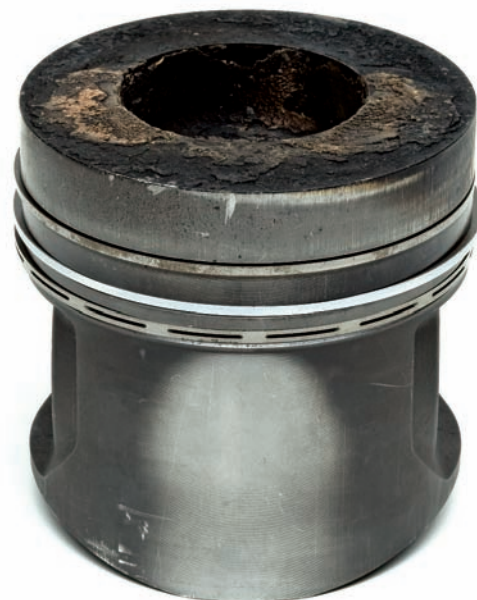
Fig. 1  
Wear caused by contamination at the piston skirt

- Check the intake system for leaks.
- Check the air filter and, if necessary, replace it.
- Clean the crankcase and the intake manifolds prior to assembly.
- Always pay attention to cleanliness during assembly.

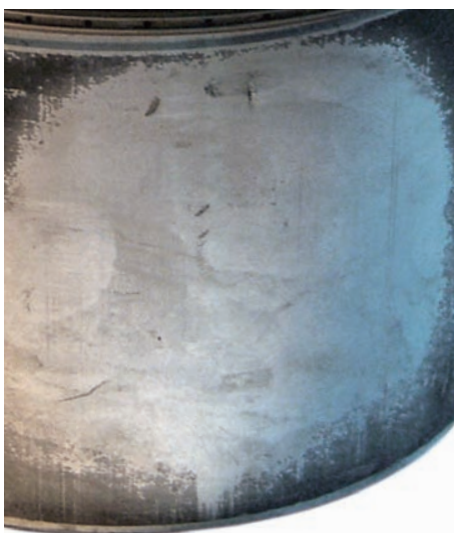
*Fig. 1*  
Wide, shiny wear pattern  
and scoring marks

- Set the injection system correctly (cold start enrichment, etc.).
- Check the injection nozzles.
- Always observe installation dimensions.
- Always adhere to fuel filter maintenance intervals, and shorten intervals accordingly in extreme conditions.
- Check the spark plugs and, if necessary, replace them.

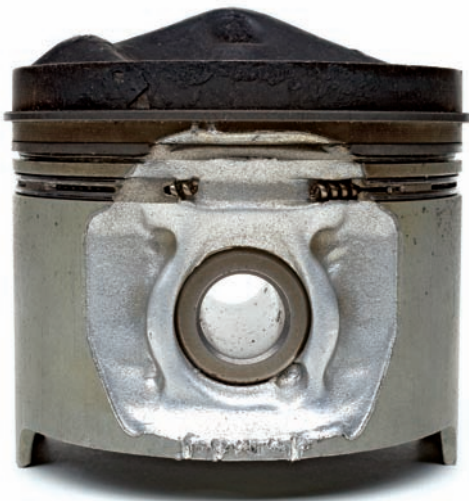
Fig. 1a  
Cratered piston wall, caused by a loose piston pin circlip or contamination in the piston pin

- When installing the circlips, ensure that the circlip ends face “6 o’clock” or “12 o’clock”.
- Always fit new, perfectly shaped circlips.
- Never use force to insert the piston pin, e.g. with a hammer.
- Make sure the bores are parallel before assembling the connecting rod.

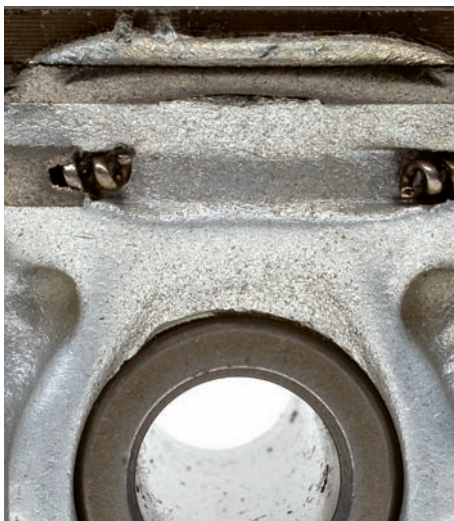
Fig. 1b  
Close-up surface view of softer piston material and harder piston ring material worn to the same extent

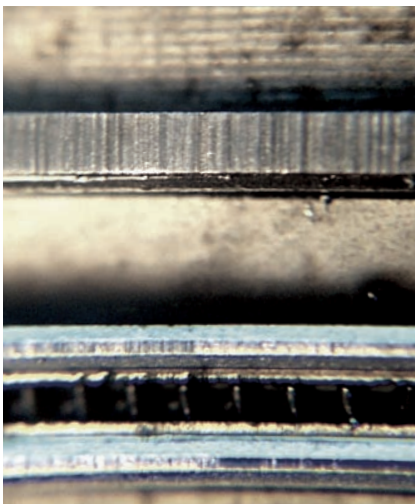
*Fig. 1*  
Piston rings with scoring marks and burn marks

Avoid high speeds or high loads at low speeds (RPM's) during the break-in phase.

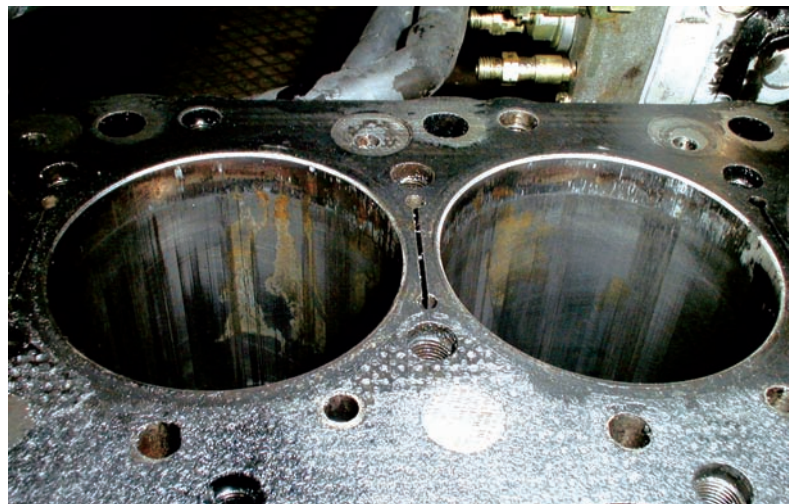
*Fig. 2*  
Cylinder bore with longitudinal scoring marks

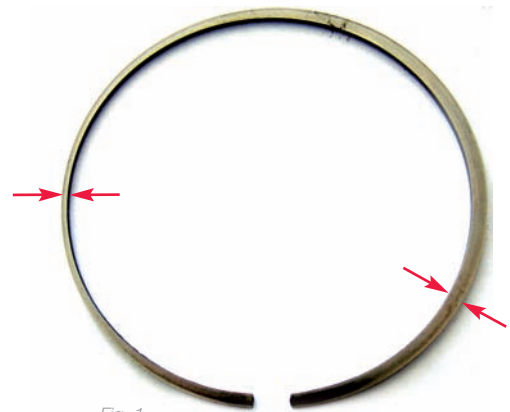
Fig. 1  
Piston ring with heavy radial wear

- Check the intake system for leaks.
- Check the air filter and, if necessary, replace it.
- Clean the crankcase and the intake manifolds prior to assembly.
- Always pay attention to cleanliness during assembly.

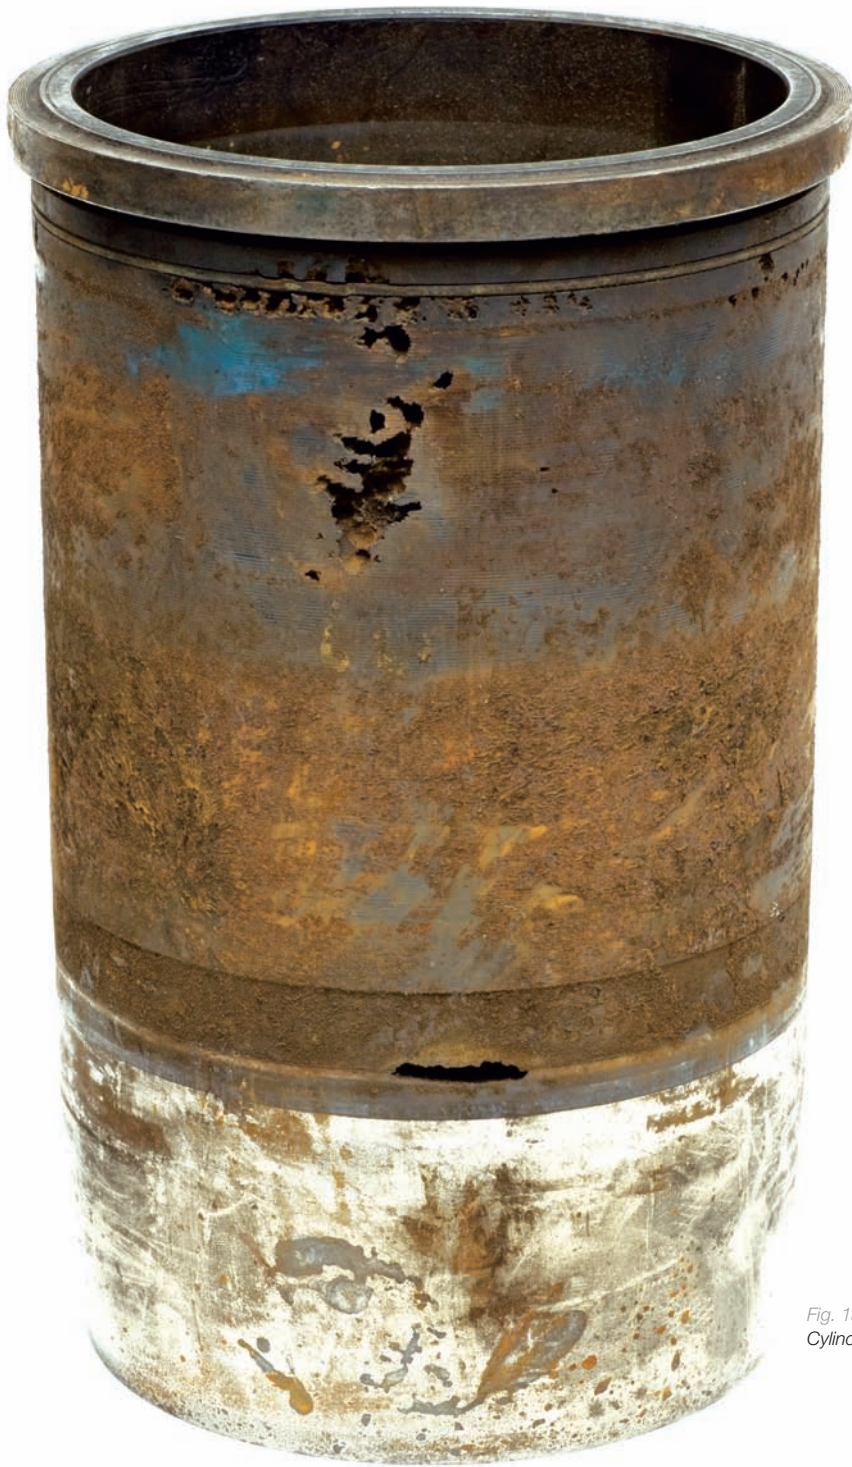
*Fig. 1a*  
Cylinder liner with cavitation damage

- Always check the cooling system (radiator cap, hoses, clamps) for leaks.
- Ensure there is sufficient anti-freeze with corrosion protection.
- Make sure the cooling system is functioning correctly (thermostat, fan, thermo switch).

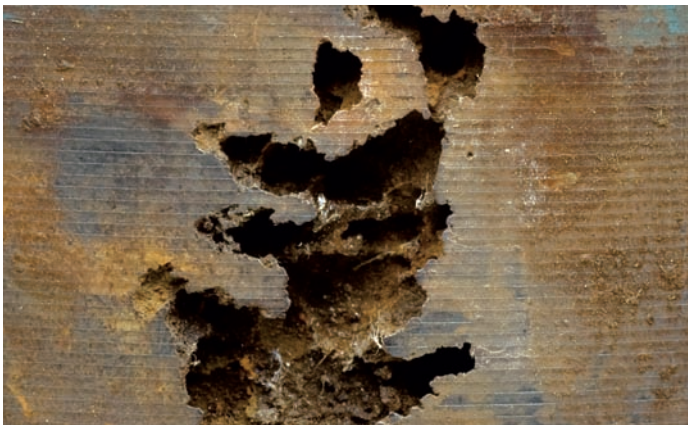
*Fig. 1b*  
Close-up view of the cylinder liner with sharp edges and cavities which become larger towards the inside

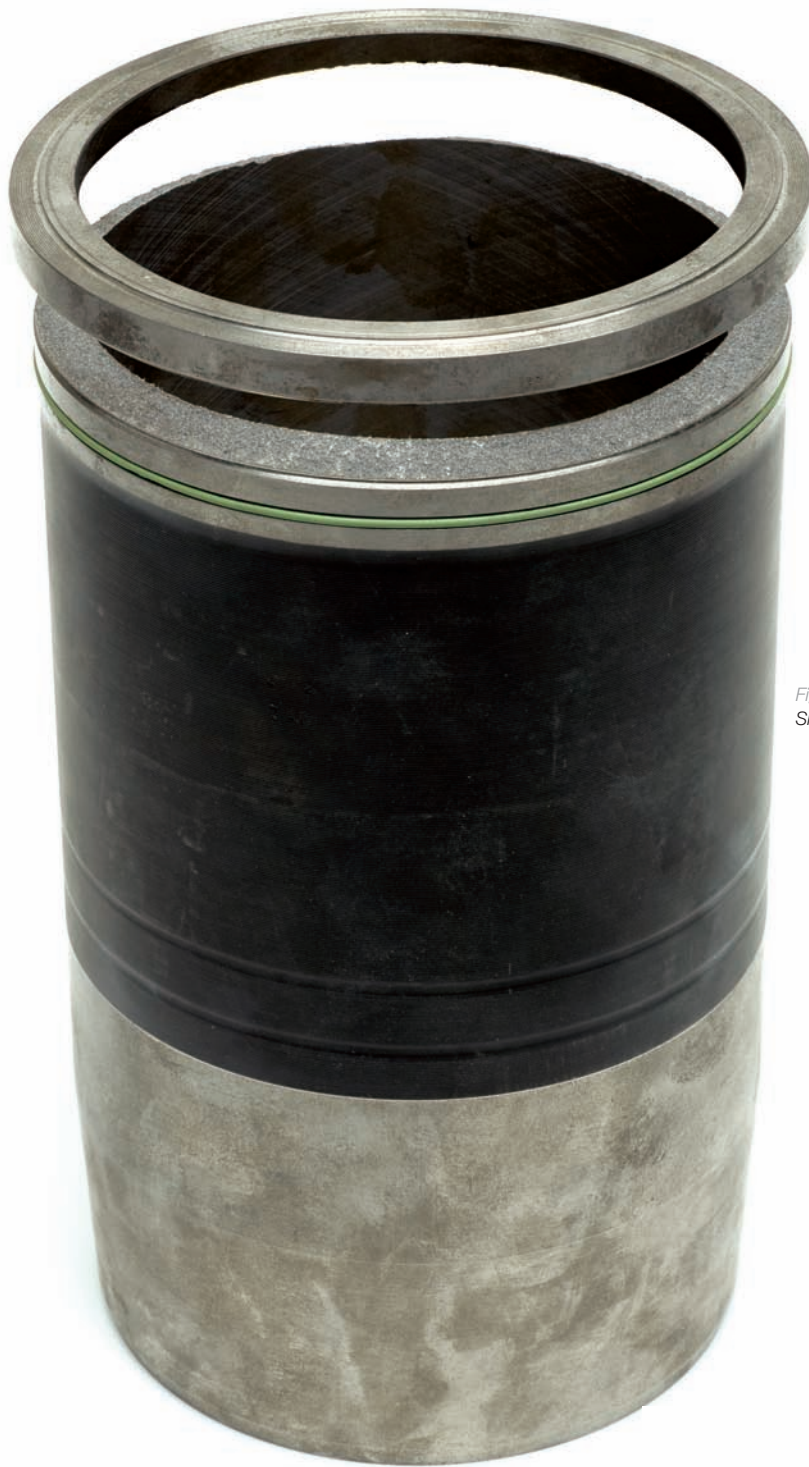
Fig. 1  
Snapped off cylinder liner flange

- Always ensure precise machining of the flange seat in the engine block.
- Make sure that the cylinder liner seat is plane and rectangular.
- After machining, the sharp-edged seat surface must be chamfered.
- Only use the cylinder head gaskets recommended for the engine.

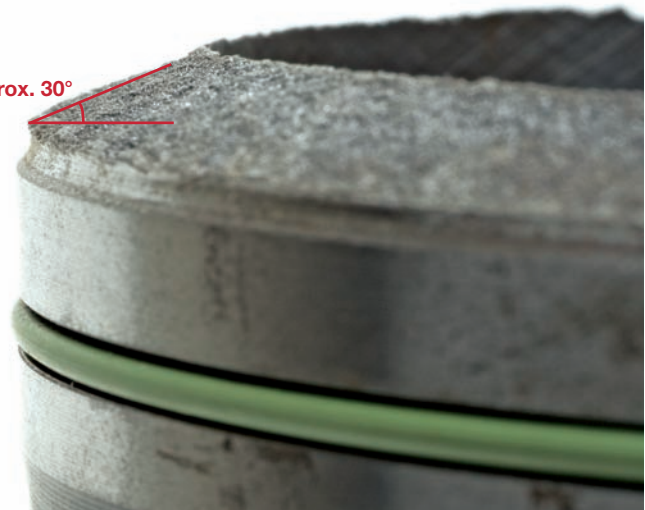
Fig. 2  
Fracture with a coarse structure at an angle of approx. 30°

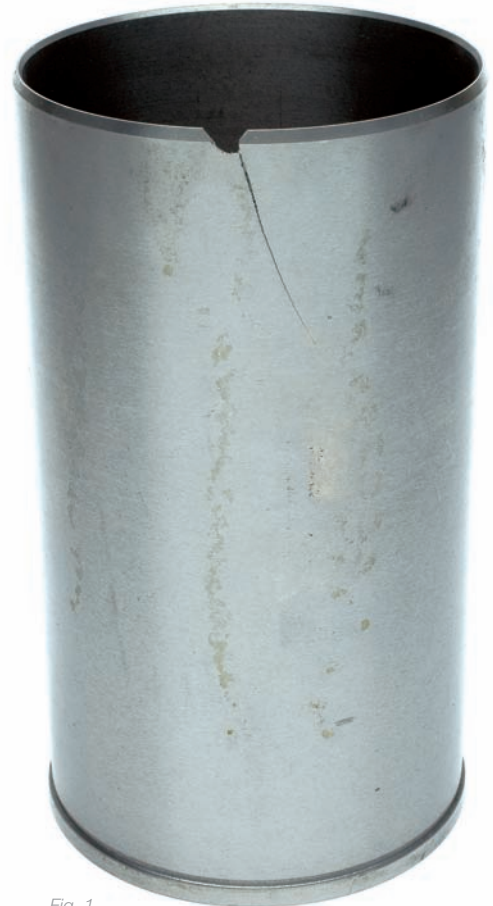
Fig. 1  
Lower end of the cylinder liner with a longitudinal crack

- Cylinder liners must be transported carefully and only in an upright position.
- Always carry out a ring test before installing the cylinder liner. Also carry out a visible inspection of the cylinder liner surface.

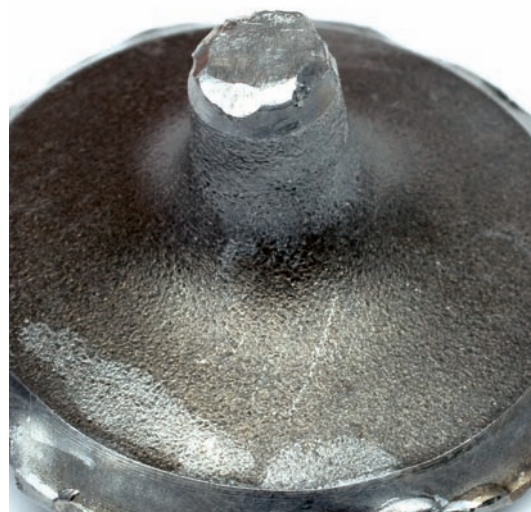
*Fig. 3*  
Vibration fracture with fracture surface at the valve stem

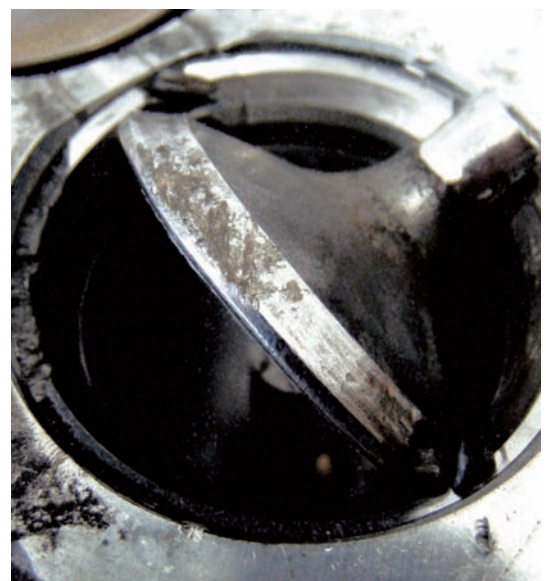
*Fig. 1*  
Snapped off valve in the valve head area

- Set the timing correctly during assembly.
- Always check the valve depth carefully during cylinder head repair work.
- Avoid over-speeding.
- If valves are reused, always check their dimensional accuracy.
- Machine the valve seat carefully, ensuring the valve guide and the valve seat are aligned correctly.

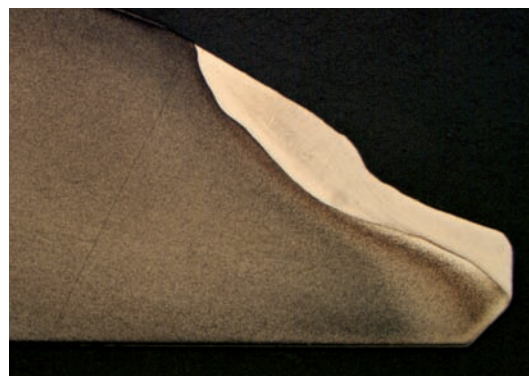
Fig. 3  
Heavily worn sealing surface (stellite hardened)

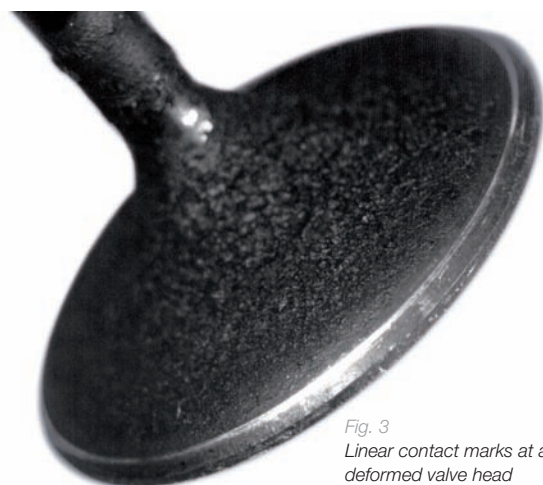
Fig. 3  
Linear contact marks at a deformed valve head

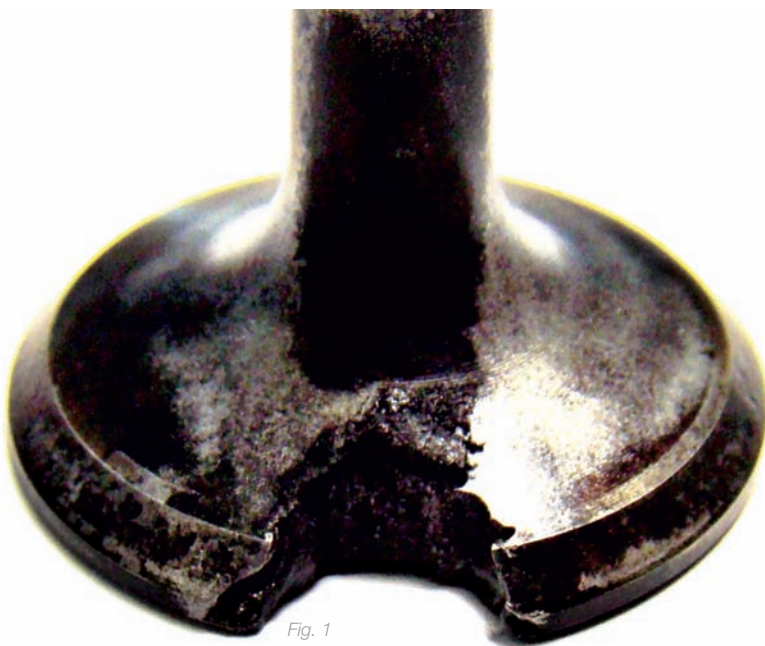
Fig. 1  
Hole burned through  
the valve

- When re-machining the valve seat, always ensure concentricity between the valve guide and the valve seat.
- Always use new valve keepers. Old valve keepers are usually worn unevenly so that the valves cannot rotate freely.
- Ream the valve guide to the specified dimension using a reamer.

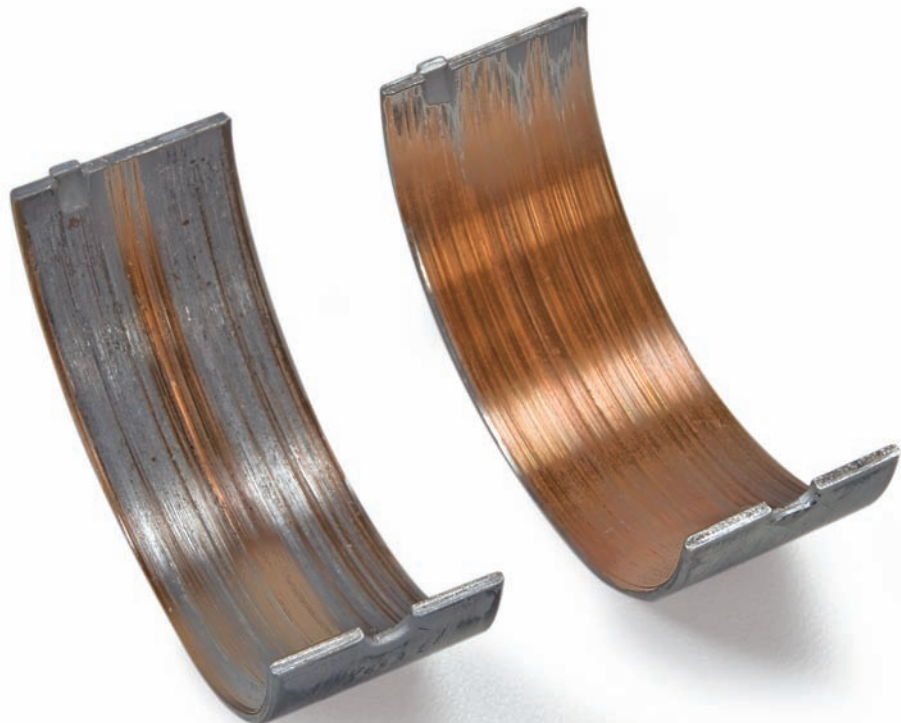
Fig. 1  
Heavy scoring in circumferential direction

- Pay great attention to cleanliness when repairing or assembling the engine.
- Only use top quality filters.
- Clean and/or renew the oil mist separator.
- Carry out maintenance at regular intervals according to the manufacturer's specifications.

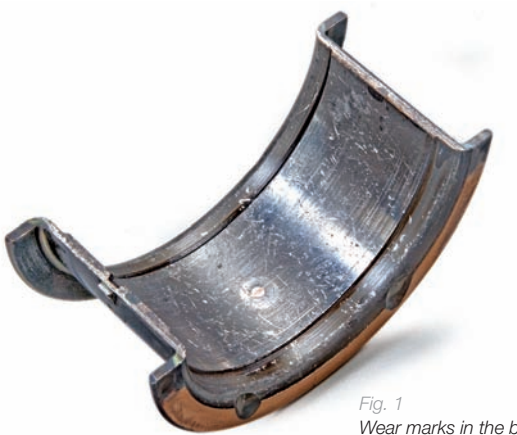
Fig. 1  
Wear marks in the bearing center

- Pay great attention to cleanliness during bearing assembly. Clean the bearings with a leather cloth prior to installation.
- Carefully debur the oil holes after machining the crankshaft pins.

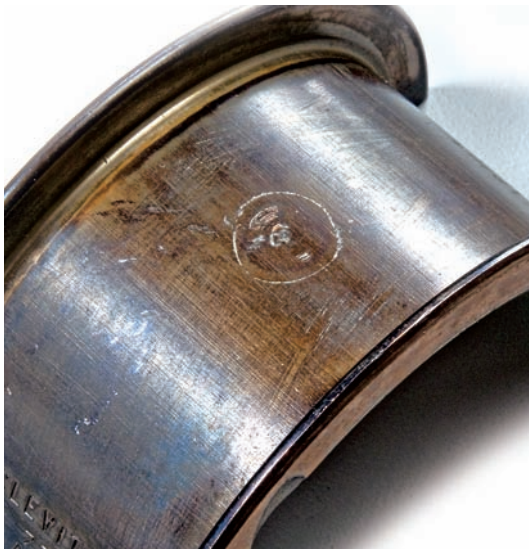
Fig. 2  
Contamination imprint on the outer surface of the bearing
