**MAHLE**

# ENGINE COMPONENTS AND FILTERS: DAMAGE PROFILES, PROBABLE CAUSES AND PREVENTION

Technical Information

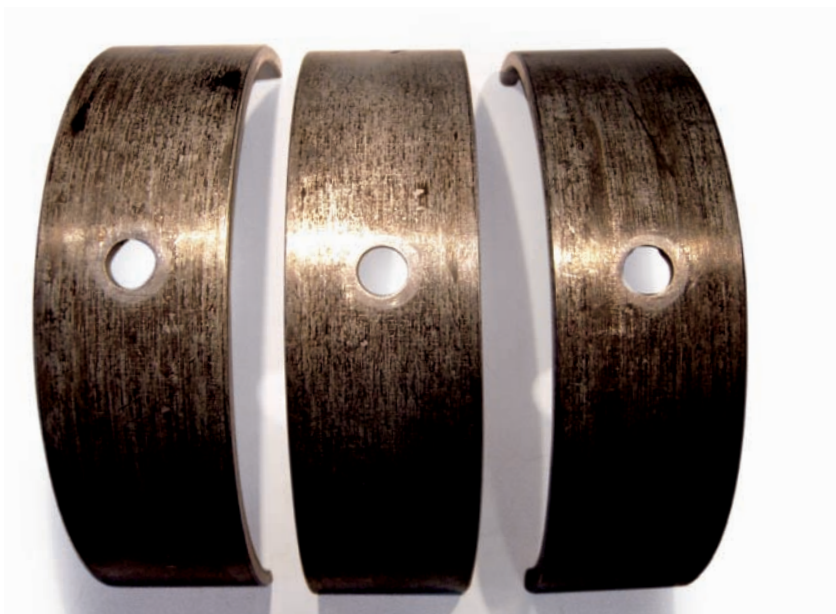
Fig. 1  
Shiny marks on the outer surface of the bearing

- Pay great attention to cleanliness during bearing assembly. Clean the bearings and the parting line of the bearing seat with a leather cloth prior to installation.
- Check the bolts of the bearing cap according to the manufacturer's specifications and, if necessary, renew them.
- Tighten the bolts of the bearing cap according to the manufacturer's specifications (tightening torque, angle of rotation).

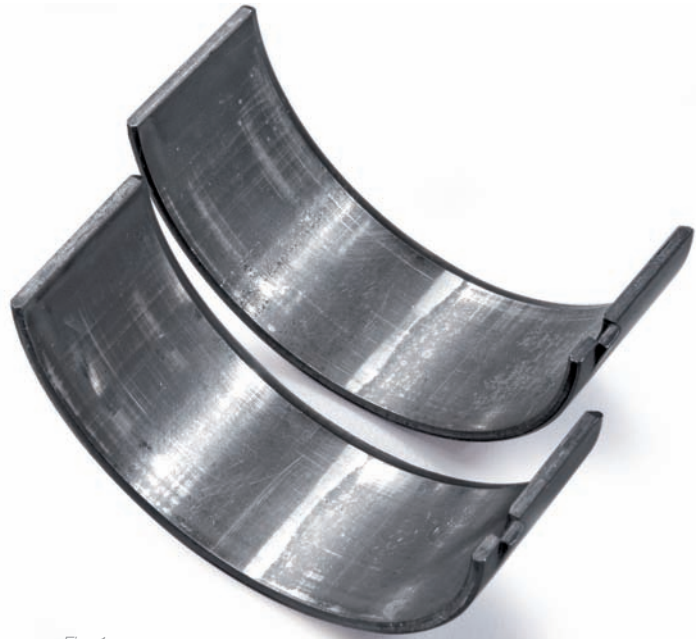
*Fig. 1*  
Worn outer edges of a bearing

- Re-machine the bearing pins to the dimension stipulated by the manufacturer.
- Pay attention to the correct position of the bearings during installation.

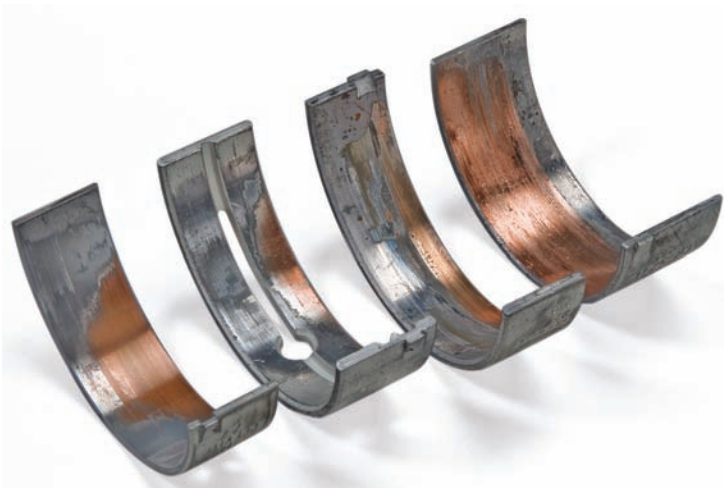
Fig. 1  
Uneven wear at the bearings

- Ensure that the engine is cooled sufficiently (coolant, oil, cooling oil nozzles, thermostat, fan).
- Tighten all the bolts according to the manufacturer's specifications. Pay attention to the specified tightening sequence.
- Align the crankshaft perfectly or replace it prior to installation.

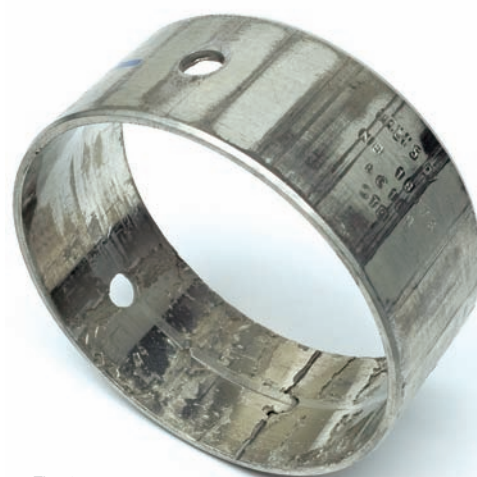
Fig. 1a  
Pitting caused by mechanical overload or inadequate load-bearing ability of the oil film

- Only use engine oils approved by the engine manufacturer.
- Always check the correct angle of the connecting rods prior to installation and, if necessary, align them.
- Cylindrically grind the crankshaft pins.

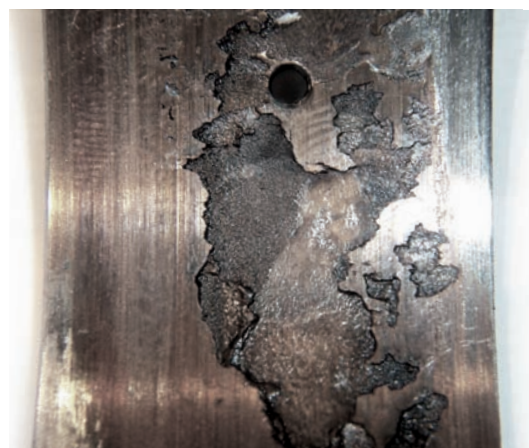
Fig. 1b  
Close-up view of the damaged bearing layer

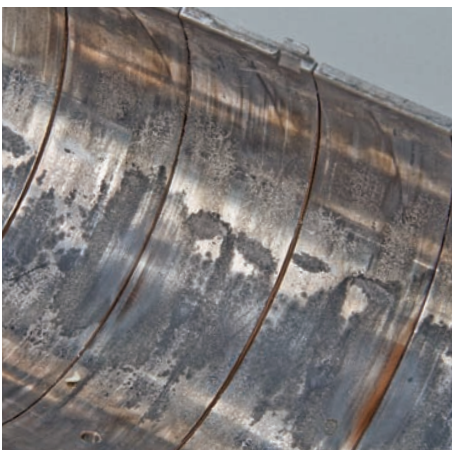
Fig. 1a  
Burned bearing surface due to chemically aggressive substances in the oil

- Always carry out the oil change according to the manufacturer's specifications.
- Regularly check the cooling system for leaks or loss of water.

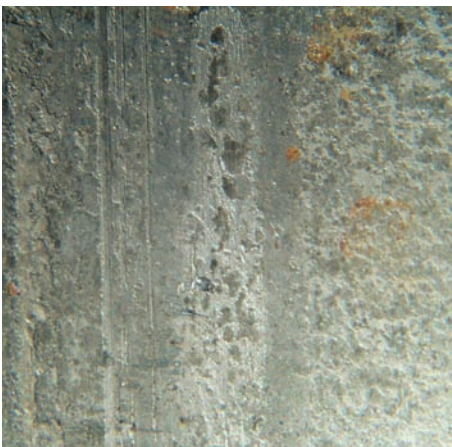
Fig. 1b  
Clearly visible in the close-up view: The corroded bearing material

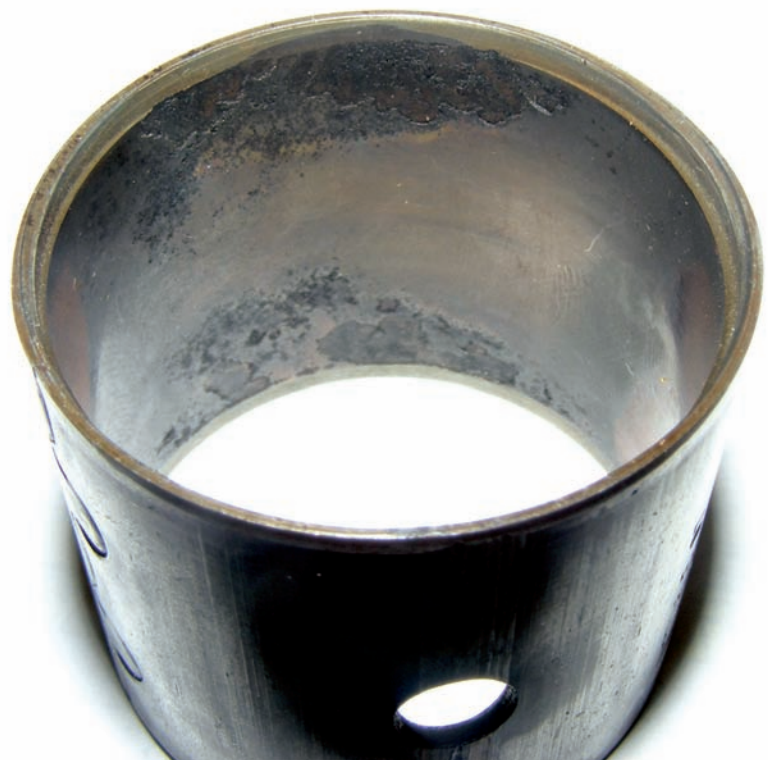
Fig. 2  
Damaged connecting rod bushing

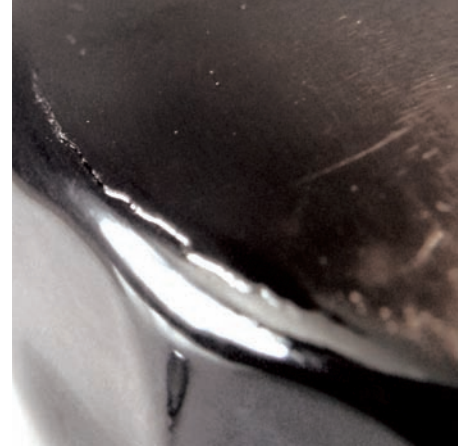
- With aluminum housings, contact corrosion between the aluminum and the retaining clamp of the filter can occur due to the protective filter film being removed or damaged (Fig. 6), resulting in the filter being leaky.
- Corrosion or leakage at the line connection can occur due to the following assembly errors:
  - The o-ring is porous, has not been replaced or slipped during assembly.
  - The hoses are not correctly connected to the fittings.
  - The hose clamps are tightened insufficiently.

Fig. 1  
Crack in the filter housing due to overload caused by pressure fluctuations

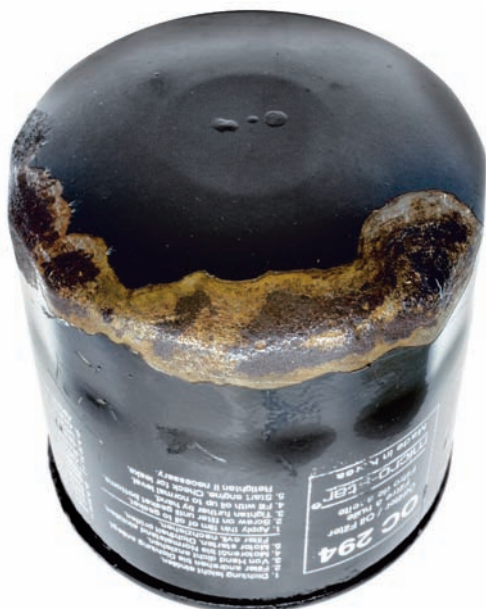
Fig. 4  
Damaged coating – the result: Corrosion

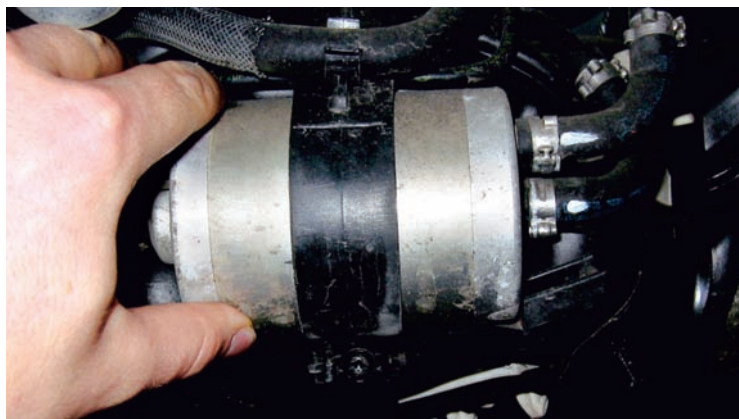
Fig. 6  
Contact corrosion due to damaged insulation

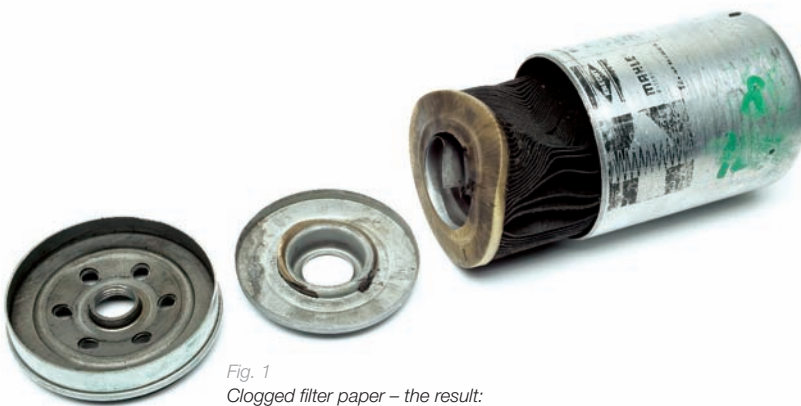
Fig. 1  
Clogged filter paper – the result:  
Collapsed filter element

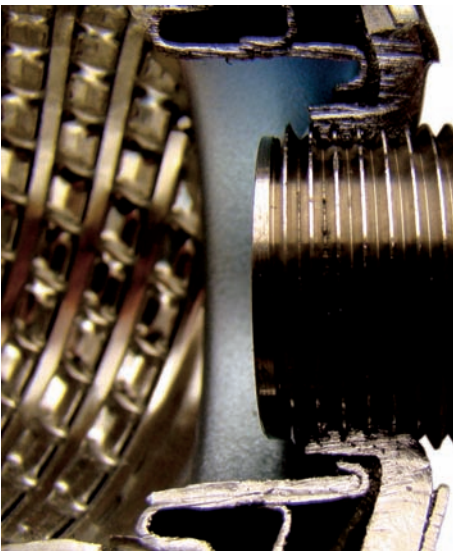
Fig. 1  
Correct thread length

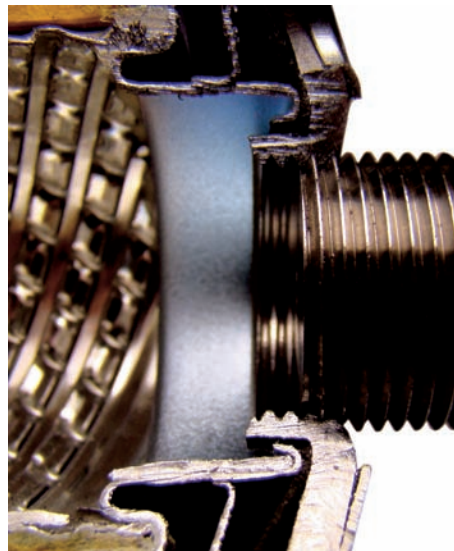
Fig. 2  
Incorrect thread length due to loose conternut

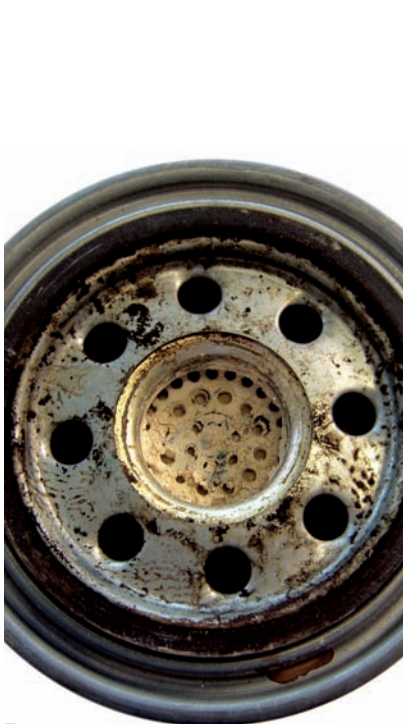
Fig. 1  
Granules escaping from the air dryer cartridge
