# An experimental study of diesel engine cam and follower wear with particular reference to the properties of the materials

J. Michalski \*, J. Marszalek, K. Kubiak

*Faculty of Mechanic Engineering and Aeronautics, Rzeszów University of Technology, 35-959 Rzeszów, ul. W. Pola 2, Poland*

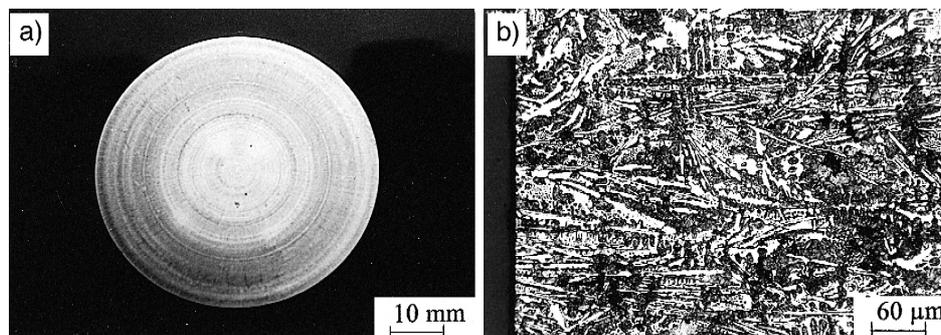
Fig. 3. Follower F1. Macrograph of the face surface (a), microstructure of the surface layer-transformed ledeburite (b).

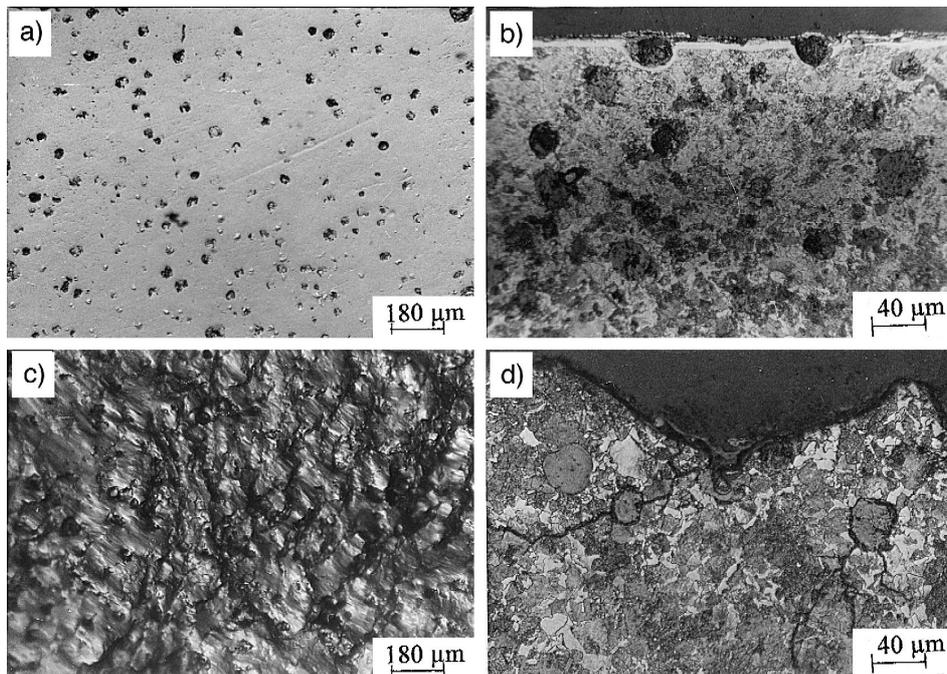
graphite phase (Fig. 6d). The process of microcracking under the scaled surface is of similar nature (Fig. 6c). It should be assumed that the pattern of graphite phases may also be a place where cracks occur and surface scaling begins.

The formation of a nitrided layer on the hard and thick martensitobainitic matrix of cams C5 ensures its small radial wear (Table 5). The cam undergoes smooth abrasive wear (Fig. 6a). Follower F3 also undergoes smooth abrasive wear of a small value. The application of sulfonitriding is not recommended because of the increased wear on the cam and follower despite smaller resistance to motion

Fig. 6. Cams C4 and C5. Smooth worn surface of shaft C5 after  $0.8 \cdot 10^6$  revolutions (a), ion nitrided diffusion layer of shaft C5 together with pearlite, ferrite and nodular graphite structures after  $0.8 \cdot 10^6$  revolutions (b), scaled C4 shaft surface after sulfonitriding together with pearlite, ferrite and nodular graphite structures (c), down-to-the base cracks propagating from the scaled C4 shaft surface after sulfonitriding (d).

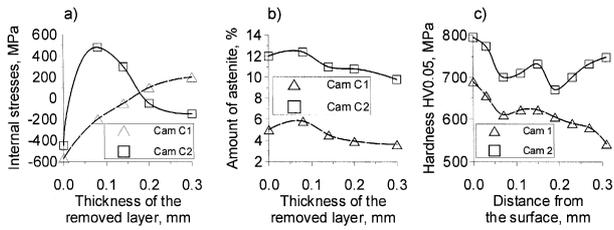
Fig. 7. Change in internal stress (a), participation of retained austenite (b), microhardness (c) in the function of the distance from the surfaces of cams C1 and C2.

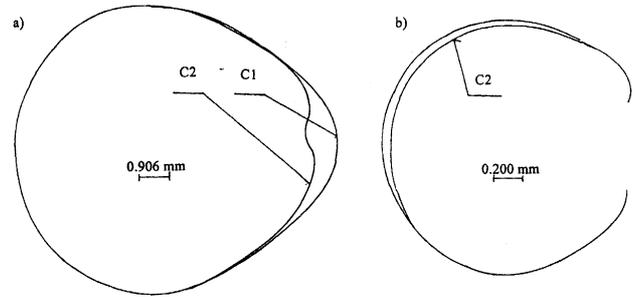
tear-outs and some delamination wear on the surface and the cementite plates were broken (Fig. 5b). The typical shapes of cams C2 and C1 also show that after wear, the attack side wore more than the taper one (Fig. 9).

Fig. 9. Outlines of worn out C1 and C2 cams (a), outlines of a fragment of a worn out C2 cam with its outline before the lift test (b).

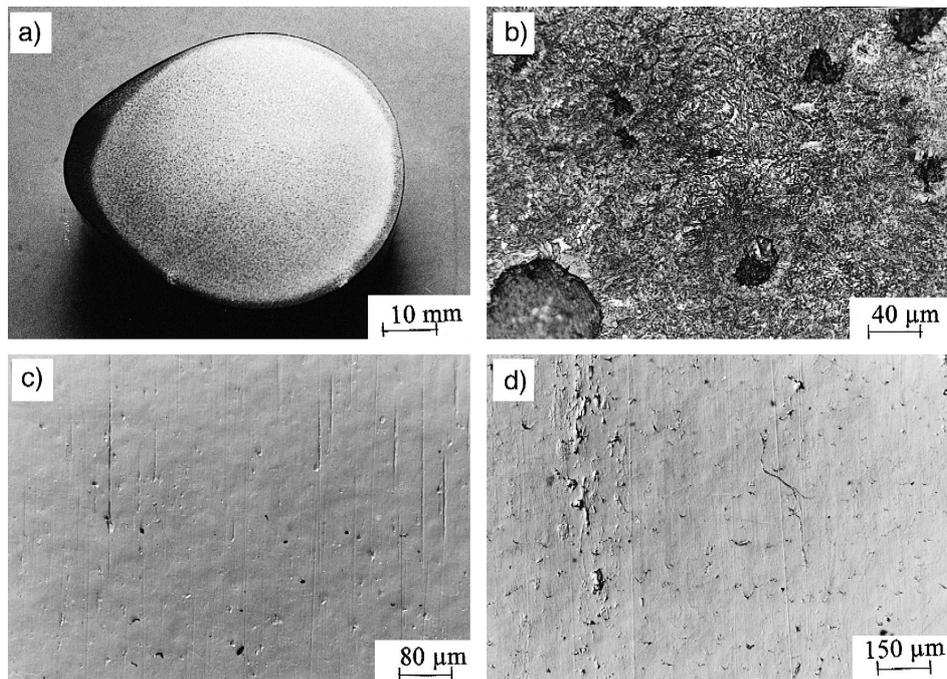
Fig. 8. Cam C1. Crosssection with a dark hardened layer on the circumference (a), hardened layer-nodular graphite, fine-acicular martensite (b), the surface of a cam flank with smooth abrasive wear (c), a strip of chippings and surface originated cracking on the shaft (d).

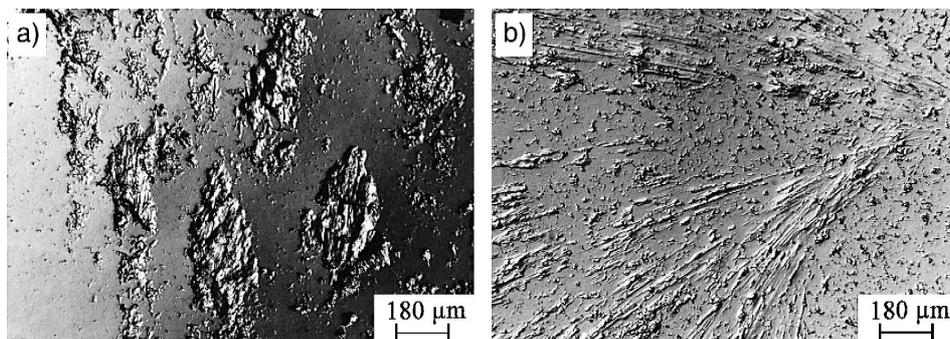
chills. The microstructure of this part of the cam consists of transformed ledeburite: cementite crystals and pearlite grains. The hardness of the cam surface is 0.4–1 HRC. Follower F4 was made of chilled and hardened grey cast iron. The hardness of its face surface is 58–59 HRC. The microstructure is martensite and cementite. Cam C7 shows smooth abrasive wear on the flanks (great surface smoothness) and has small carbide peelings. Its lobe shows great abrasive wear and has a few cavities after chipped hard particles (cementite) and considerable cavities after the separation of large flakes of metal (Fig. 10a). Follower F4 has an evenly worn face surface with small cavities caused by chipped cementite particles and large, groove shaped cavities which might have been caused by hard particles torn out of the cam surface (Fig. 10b).

Fig. 10. Surfaces of cam 7 and follower F4. The lobe of the cam with metal fragments torn off the surface layer and chipped cementite particles (a), follower with cementite chippings and traces of surface deformation by hard particles (b).
