**MAHLE**

# ENGINE COMPONENTS AND FILTERS: DAMAGE PROFILES, PROBABLE CAUSES AND PREVENTION

Technical Information

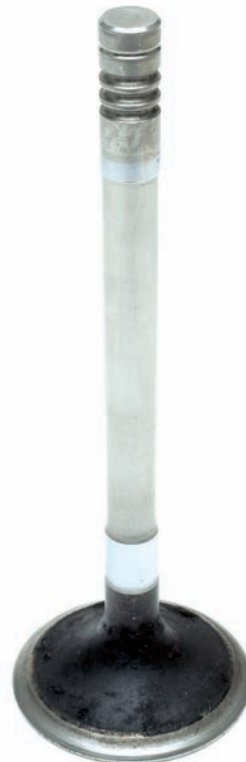
Fig. 7  
Heavily worn valve stem

- Check the intake system for leaks.
- Check the air filter and, if necessary, replace it.
- Clean the crankcase and the intake manifolds prior to assembly.
- Always pay attention to cleanliness during assembly.

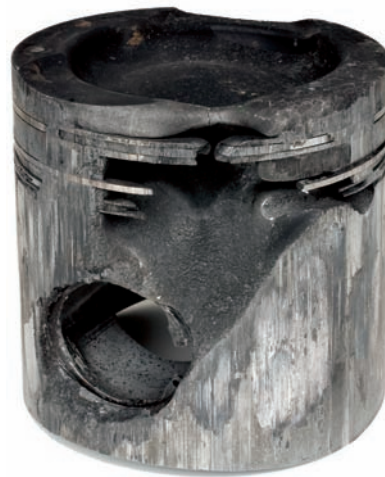
Fig. 3  
Hole burned through a diesel piston

- Set the injection amount and timing according to the manufacturer's specifications.
- Check the injection nozzles for any leaks, the injection pressure and the spray pattern.
- Pay attention to correct alignment when assembling the cooling oil nozzles.
- The time between oil changes must be much shorter when running the engine on biofuels.
- Thoroughly clean the oil channels in the engine block, the crankshaft and the cylinder head.
- Make sure the pressure regulating valve is functioning correctly.

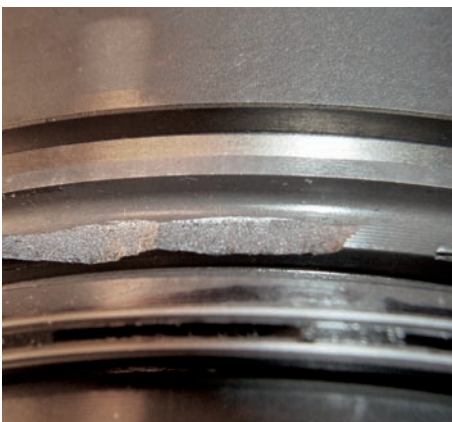
Fig. 2  
Broken piston ring lands caused by an assembly error

- Only use fuel with the specified octane rating.
- Set the injection system, the carburetor and the ignition correctly.
- Only use spark plugs which correspond to the manufacturer’s specifications.
- Check the intake system for leaks.
- Use a thicker gasket for a re-machined cylinder head, and ensure the compression height is less for oversize pistons.
- Pay attention to the correct charge-air pressure for a turbocharged engine.
- Always use new and undamaged gaskets when overhauling an engine, and do not forget to replace relevant gaskets.
- Always check injection nozzles and, when necessary, renew them.

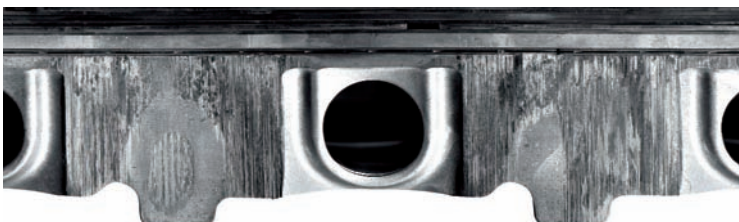
Fig. 1  
Seizure at the piston skirt, caused by insufficient clearance

- Always observe the correct cylinder size. This can be determined using the values stated on the piston (piston diameter plus fitting clearance).
- Check the coolant circuit, this includes:
  - Coolant level
  - Water pump (V-belt)
  - Thermostat
  - Fan
- Deaerate the cooling system. This also includes the heating circuit.

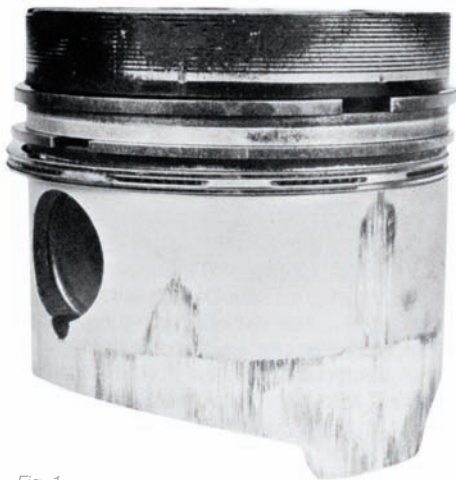
Fig. 1  
Seizure at the lower piston skirt due to constriction of the cylinder liner

- Tighten the cylinder head bolts according to the tightening torque specifications.
- To prevent a lack of clearance or cylinder distortion, install wet cylinder liners without gaskets first. This ensures that a lack of clearance can be detected in good time. Subsequently insert the cylinder liner together with the gaskets.
- Set the honing machine correctly. Measure the cylinder bore at the top, middle and bottom, also in two directions, during and after honing.

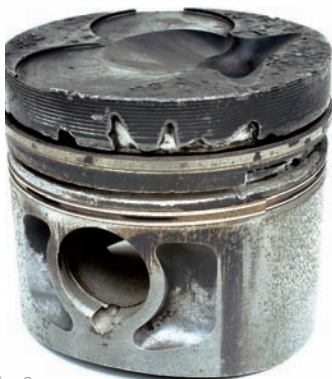
Fig. 3  
Damage to the top of the piston due to individual fragments of the ring insert

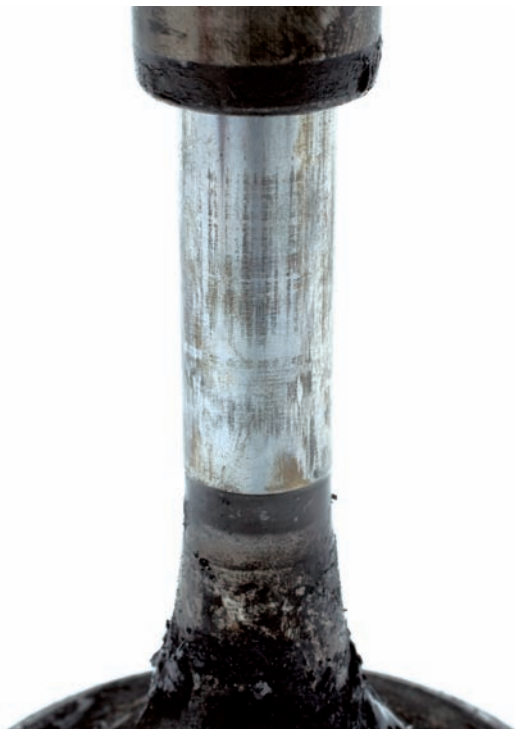
*Fig. 1b*  
Clearly visible in the close-up view: Deposit build-up and seizure marks on the valve stem

- Align the valve guide and the valve seat correctly.
- When re-machining used valves, pay great attention to a straight valve stem.
- Install the valve seat inserts according to the manufacturer's specifications.
- Always use new valve keepers. Old keepers are usually worn unevenly so that the valves cannot rotate freely.
- Always machine valve guides to specified dimensions according to the manufacturer's instructions.
- After running the engine above the rated speed, it is advisable to check the entire valve train system and the top of the piston for damage.

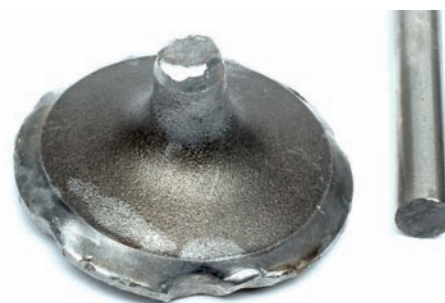
*Fig. 2*  
Snapped off valve head

- Set the valve clearance correctly.
- Avoid running the engine above the rated speed.
- Set the timing correctly.
- Always renew the clamping device when replacing timing belts or chains.
- After machining the cylinder head, always check the valve depth.

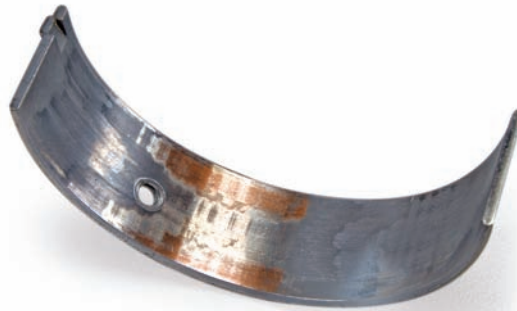
One or several bearings show uneven wear patterns – either only on the edge or only in the center of the bearing (Fig. 1–2).

Fig. 1  
Uneven wear at the bearings, the bearing layer has been partially removed

- Always check the correct angle of the connecting rods prior to installation and, if necessary, align them.
- Cylindrically grind the crankshaft pins.

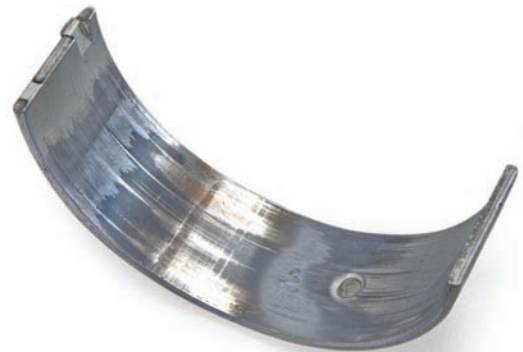
Fig. 2  
Uneven wear at the bearings

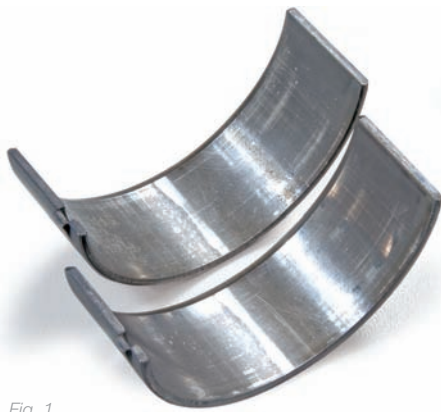
Fig. 1  
Shiny marks on the running surfaces of the bearings

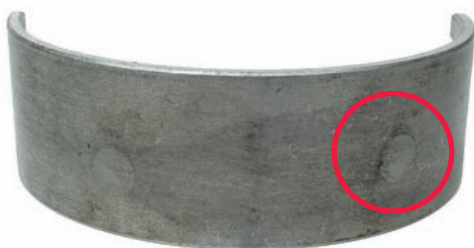
Fig. 4  
Incorrectly installed bearing – at the outer surface:  
Imprints of the oil feeder holes
