**MAHLE**

# ENGINE COMPONENTS AND FILTERS: DAMAGE PROFILES, PROBABLE CAUSES AND PREVENTION

Technical Information

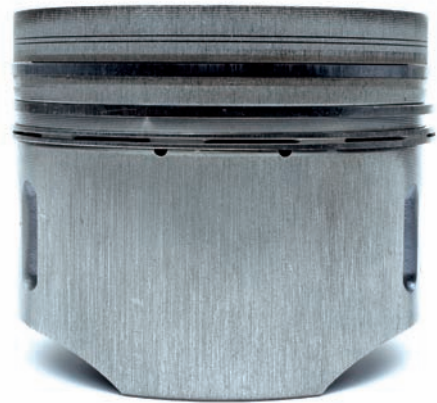
- The piston skirt displays a scuffing, wide wear pattern on the thrust and opposite side (Fig. 1).
- The machining profile at the piston skirt (Fig. 2) and at the contact surfaces (cylinder wall or cylinder liner) has been removed (Fig. 3).
- The piston skirt, piston rings, cylinder wall and/or cylinder liner display fine scoring marks in the running direction.
- The piston rings and groove walls are heavily worn (Fig. 4).
- There is a large end gap at the piston rings. The edges of the rings are razor sharp.
- The faces of the oil control ring are worn (Fig. 5).
- The piston pin shows longitudinal scoring marks with a wavelike profile (Fig. 6).
- Wear caused by contamination can also be found on other components, for example at a valve stem (Fig. 7).

Fig. 1  
Wear caused by contamination at the piston – longitudinal scoring marks

- Check the intake system for leaks.
- Check the air filter and, if necessary, replace it.
- Clean the crankcase and the intake manifolds prior to assembly.
- Always pay attention to cleanliness during assembly.

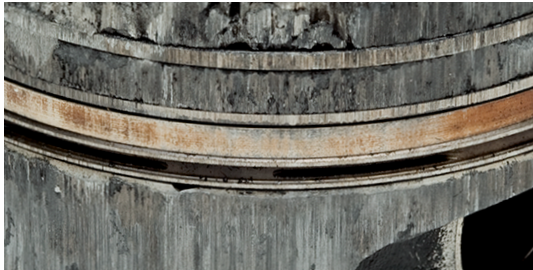
An excessive amount of fuel in the oil dilutes the oil film, thus drastically reducing its load-bearing ability and increasing engine component wear. This type of damage can have the following causes:

*Fig. 2*  
*Scoring marks and burn marks on the piston rings*

- Set the injection system correctly (cold start enrichment, etc.).
- Check the injection nozzles.
- Installation dimensions must be observed.
- Always adhere to fuel filter maintenance intervals, and shorten the time between intervals accordingly in extreme conditions.
- Check the spark plugs and, if necessary, replace them.

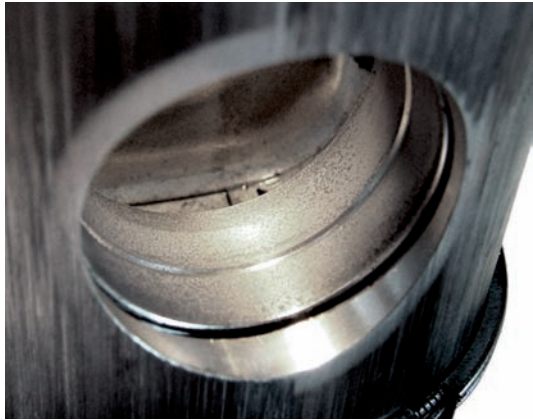
*Fig. 4a*  
*Pitting in the pin bore due to diluted engine oil*

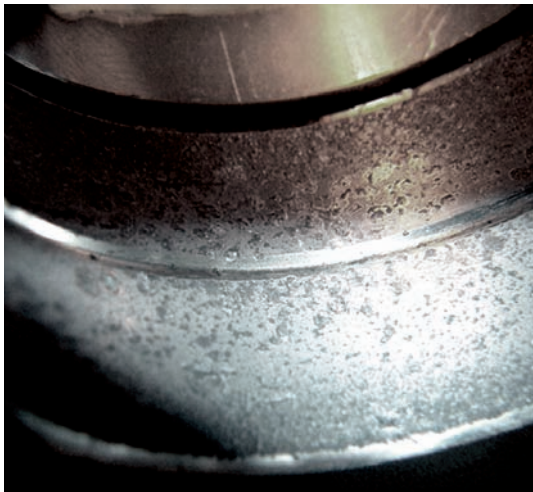
*Fig.4b*  
*Even more visible when magnified: the pitting*

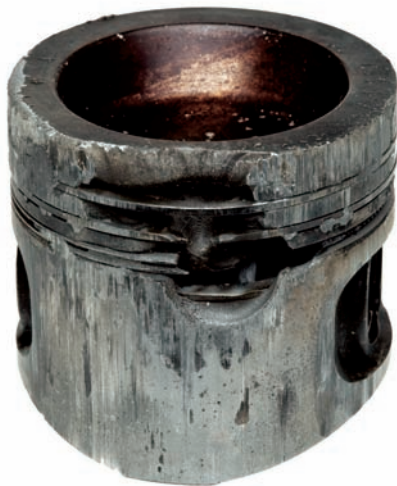
Fig. 2  
Melted top land of a gasoline piston

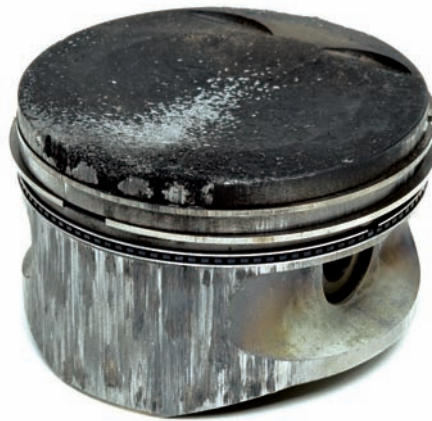
Fig. 3  
Heavy erosion and melting at the piston crown

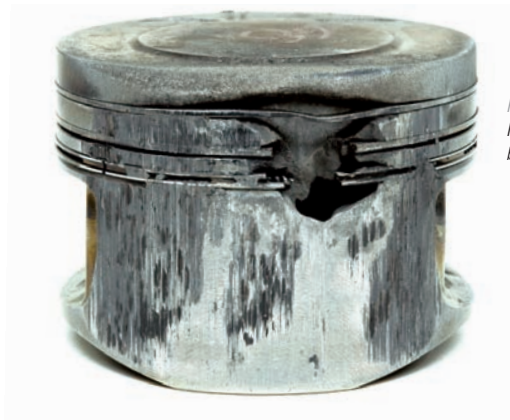
Fig. 4  
Hole melted through the piston ring belt of a gasoline piston

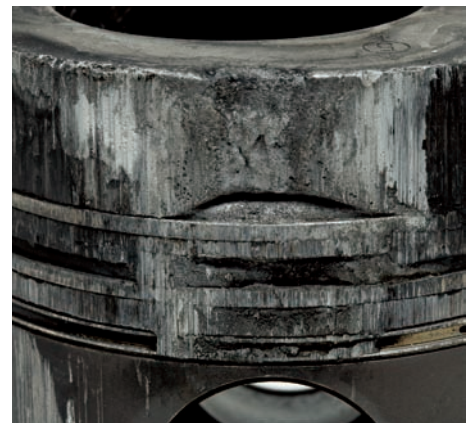
- The air-fuel mixture in the combustion chamber is too rich. This can be the result of the following:
  - The air supply is reduced, e.g. the air filter is clogged.
  - The fuel delivery is set incorrectly.
  - The start of fuel delivery is set incorrectly.
  - The nozzle needle is either wedged or stiff.
  - The exhaust gas system is clogged.
- There is ignition delay and misfiring which may be caused by the following:
  - The incorrect fuel or fuel with an insufficient cetane rating is being used, or there is gasoline in the diesel.
  - The valves are leaky, resulting in compression loss.
  - The protrusion is too small, i.e. there is insufficient compression.
  - The air pre-warming is defective (especially for very low ambient temperatures).

*Fig. 1*  
Melting at the top land of a diesel piston

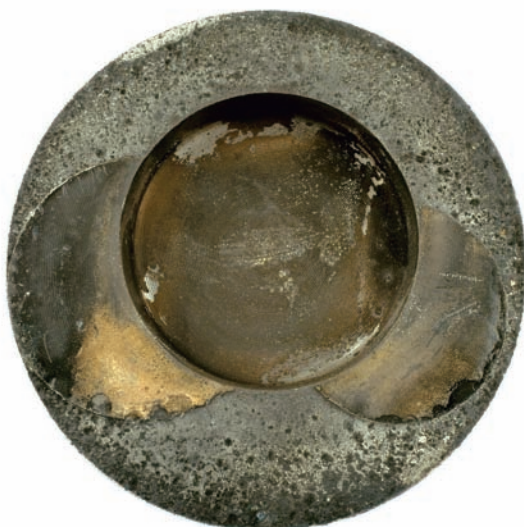
Fig. 2  
Piston which has had contact with the cylinder head

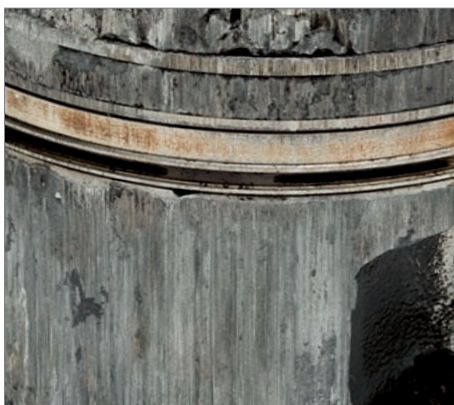
Fig. 2  
Piston rings with burn marks

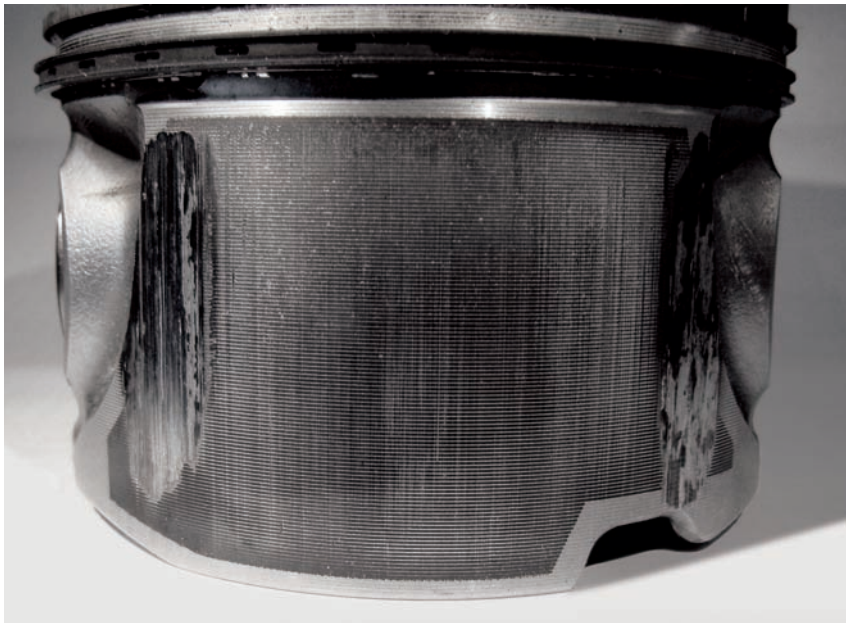
Fig. 2  
Lateral piston seizure next to the pin bore

- Always oil the connecting rod, the piston pin and the pin boss sufficiently immediately prior to engine assembly and make sure that unrestricted movement is guaranteed.
- Pump oil into the assembled engine under pressure to ensure that oil is pushed through the oil filter and all the oil feeder holes.
- Operate the engine at a moderate speed and load immediately after assembly.

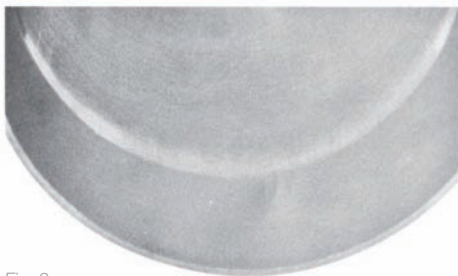
Fig. 2  
Continuous, shiny line at the cylinder bore

- Tighten the cylinder head bolts according to the tightening torque specifications.
- To prevent a lack of clearance or cylinder distortion, install wet cylinder liners without gaskets first. This ensures that a lack of clearance can be detected in good time. Subsequently insert the cylinder liner together with the gaskets.
- Set the honing machine correctly. Measure the cylinder bore at the top, middle and bottom, also in two directions, during and after honing.

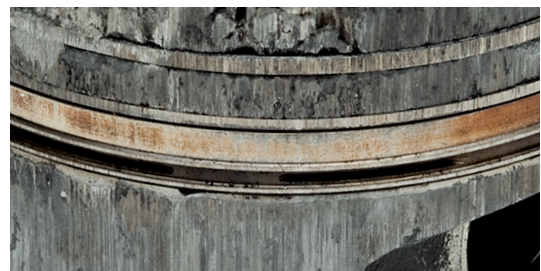
*Fig. 2*  
Scoring marks and burn marks on the piston rings

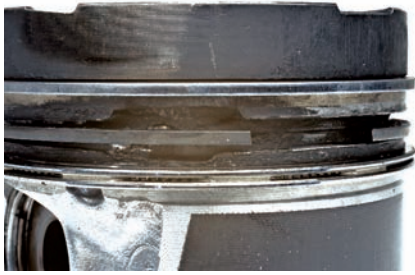
Fig. 1  
Heavily worn piston ring groove

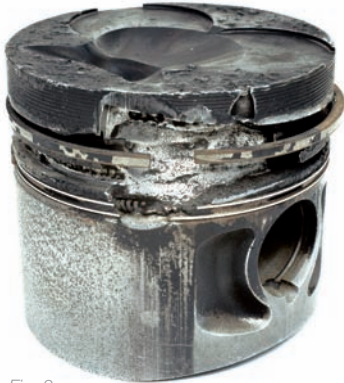
Fig. 2  
Ring belt with shiny surface

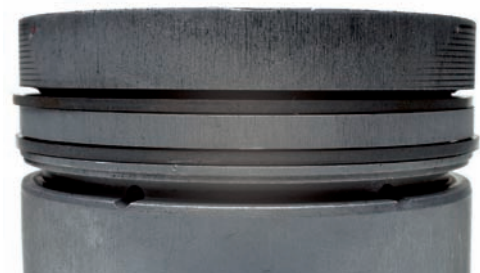
Fig. 2  
Heavy axial wear particularly at the top ring

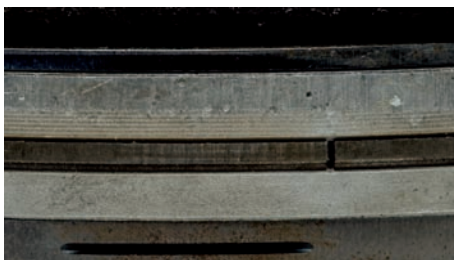
An excessive amount of fuel in the oil dilutes the oil film, thus drastically reducing its load-bearing ability and increasing engine component wear. This type of damage can have the following causes:

*Fig. 1*  
Heavy radial wear with relatively low axial wear

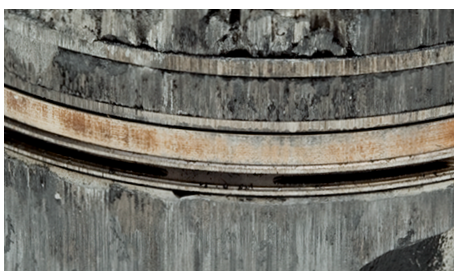
*Fig. 2*  
Scoring marks and burn marks on the piston rings

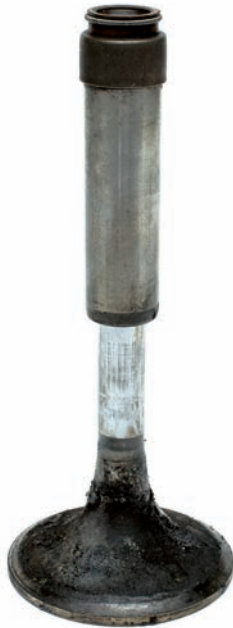
*Fig. 1a*  
Valve with seizure in the guide

- Align the valve guide and the valve seat correctly.
- When re-machining used valves, pay great attention to a straight valve stem.
- Install the valve seat inserts according to the manufacturer's specifications.
- Always use new valve keepers. Old keepers are usually worn unevenly so that the valves cannot rotate freely.
- Always machine valve guides to specified dimensions according to the manufacturer's instructions.
- After running the engine above the rated speed, it is advisable to check the entire valve train system and the top of the piston for damage.

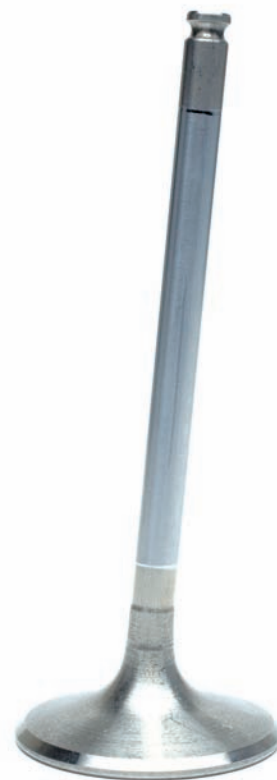
*Fig. 1*  
Bent valve stem

- Set the valve clearance correctly.
- Avoid running the engine above the rated speed.
- Set the timing correctly.
- Always renew the clamping device when replacing timing belts or chains.
- After machining the cylinder head, always check the valve depth.

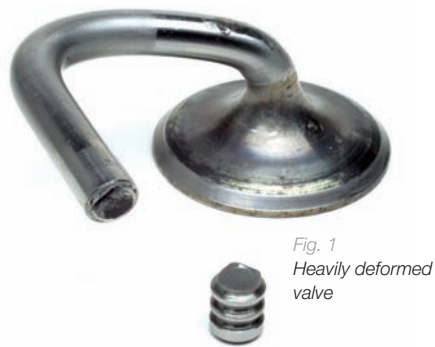
Fig. 1  
Heavily deformed  
valve

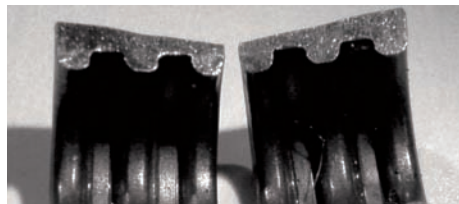
Fig. 3  
Deformation of the valve keepers at the ribs

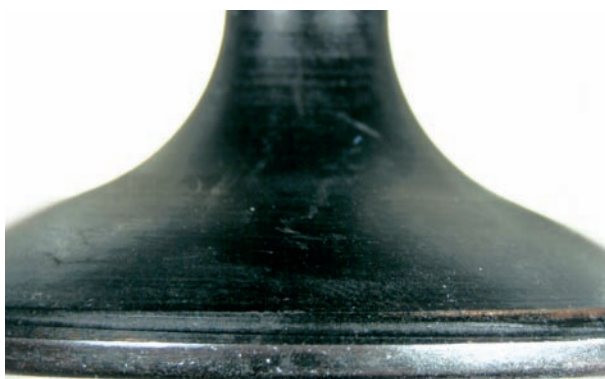
Fig. 1  
Deformed valve head (tulip-shaped)

- Set the valve clearance correctly.
- Check the injection system.
- Always remove any remaining small parts from the combustion chamber or intake passage during engine assembly.

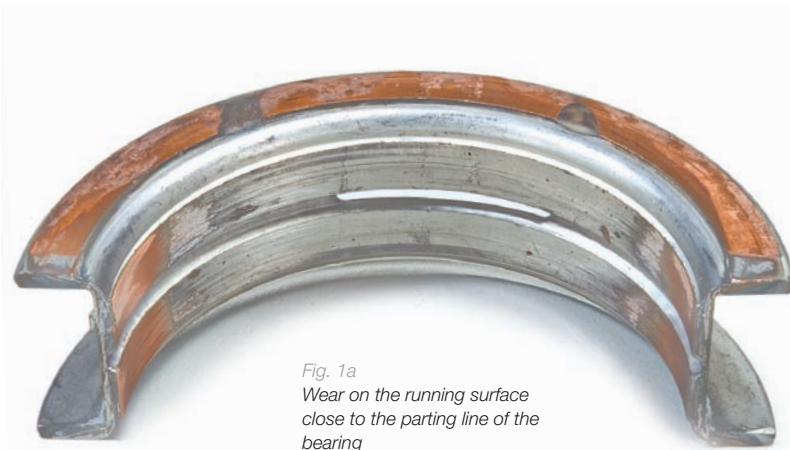
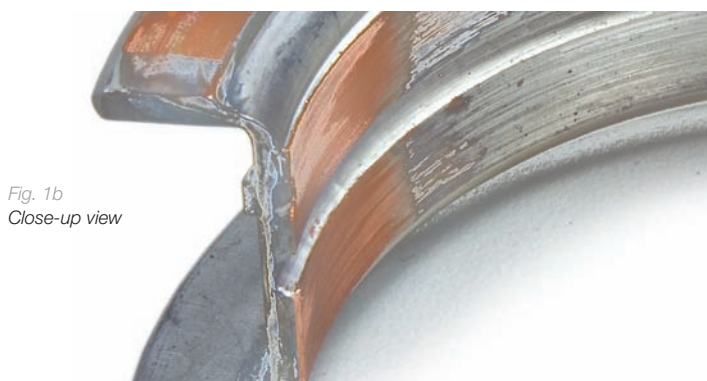
There are heavy wear marks in the area of the parting line of the bearing (Fig. 1a+b).

- The bearing cap is offset (Fig. 2). For example, this can occur when an unsuitable tool with large wrench sockets is used for tightening. It is possible that incorrect adapter sleeves/dowels have been used, the bearing bolts have been tightened with the wrong torque or the bolts have been overstretched.
- The bearing cap has been reversed or improperly fitted; it is also possible that the allocation of caps and cylinders has not been observed.
- The diameter of the holes is too small after re-machining the bearing caps.
- A used connecting rod with an oval 'big end' has been installed without the necessary re-machining of the 'big end' housing being carried out.

- Only tighten bolts with a suitable tool.
- Observe the tightening torques of the bearing bolts.
- Pay attention to the allocation of bearing caps and cylinder.
- Check the 'big end' housing and possibly re-machine it.

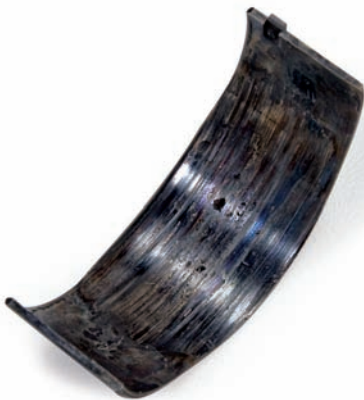
Fig. 2  
Heavily worn and spun bearing

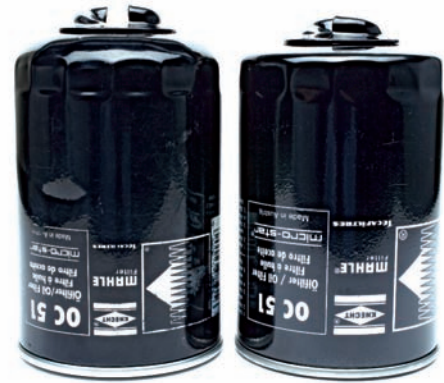
Fig. 2  
For comparison: Swollen filter (left) and new filter (right)

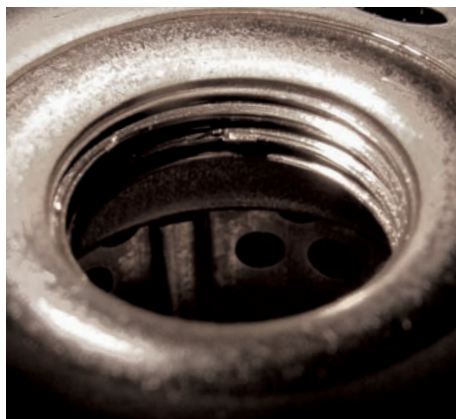
- The filter has been installed in a slanted position (Fig. 5).
- The o-ring is fitted incorrectly.
- An old o-ring has been re-used.
- The tightening torque was incorrect when installing the filter.

Fig. 5  
Damaged threads due to an incorrectly installed filter

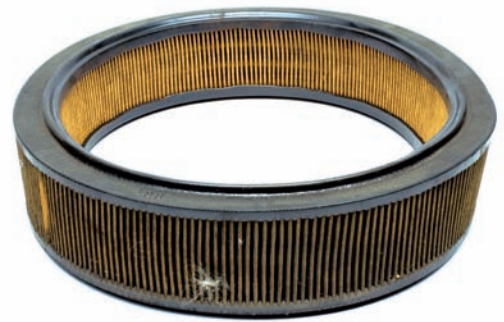
Fig. 3a  
Extremely dirty air filter element, filter change imperative

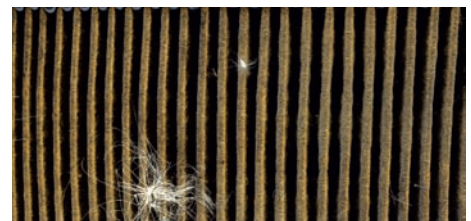
Fig. 3b  
Close-up view

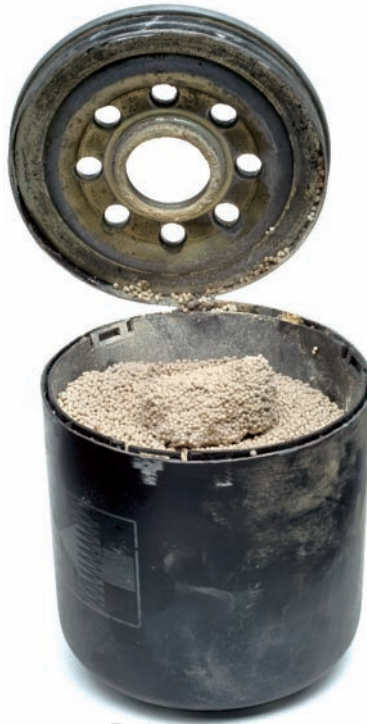
Fig. 2  
Lumpy granular material

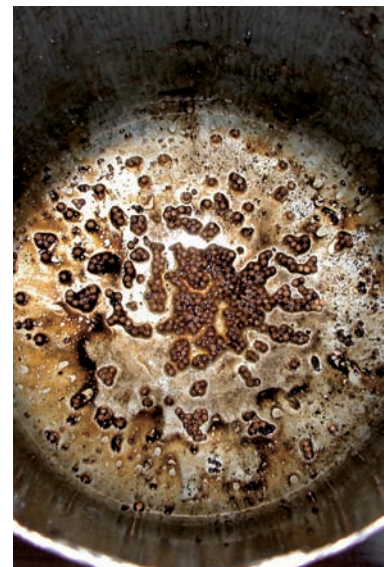
Fig. 3  
Granules, water and oil in the air dryer cartridge
